January 14-16, 2026
42nd CRCA Trade Show & Seminars

I Wouldn't Do That If I Was You...

Current Technical Roofing Issues From Field Forensics

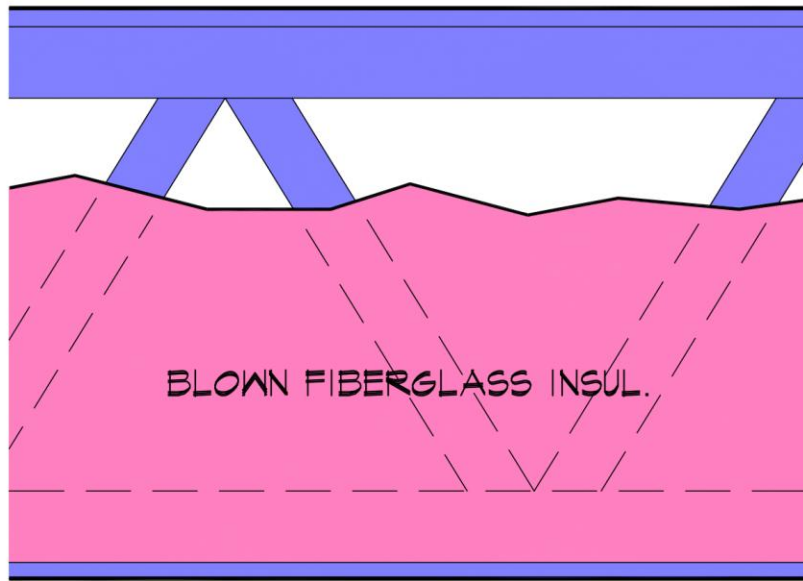
COLD ROOF

- Roof design where all or most of the insulation is below the roof deck
 - This is what most steep slope roofs are for residential homes and vented
 - Here they are in a low slope configuration
- Typically, this design was used to meet an exemption in fire code for multifamily to avoid the use of sprinkler system in interstitial space
- R-40 to R-60 of insulation results in this space
 - Incredibly energy efficient!
 - Right?

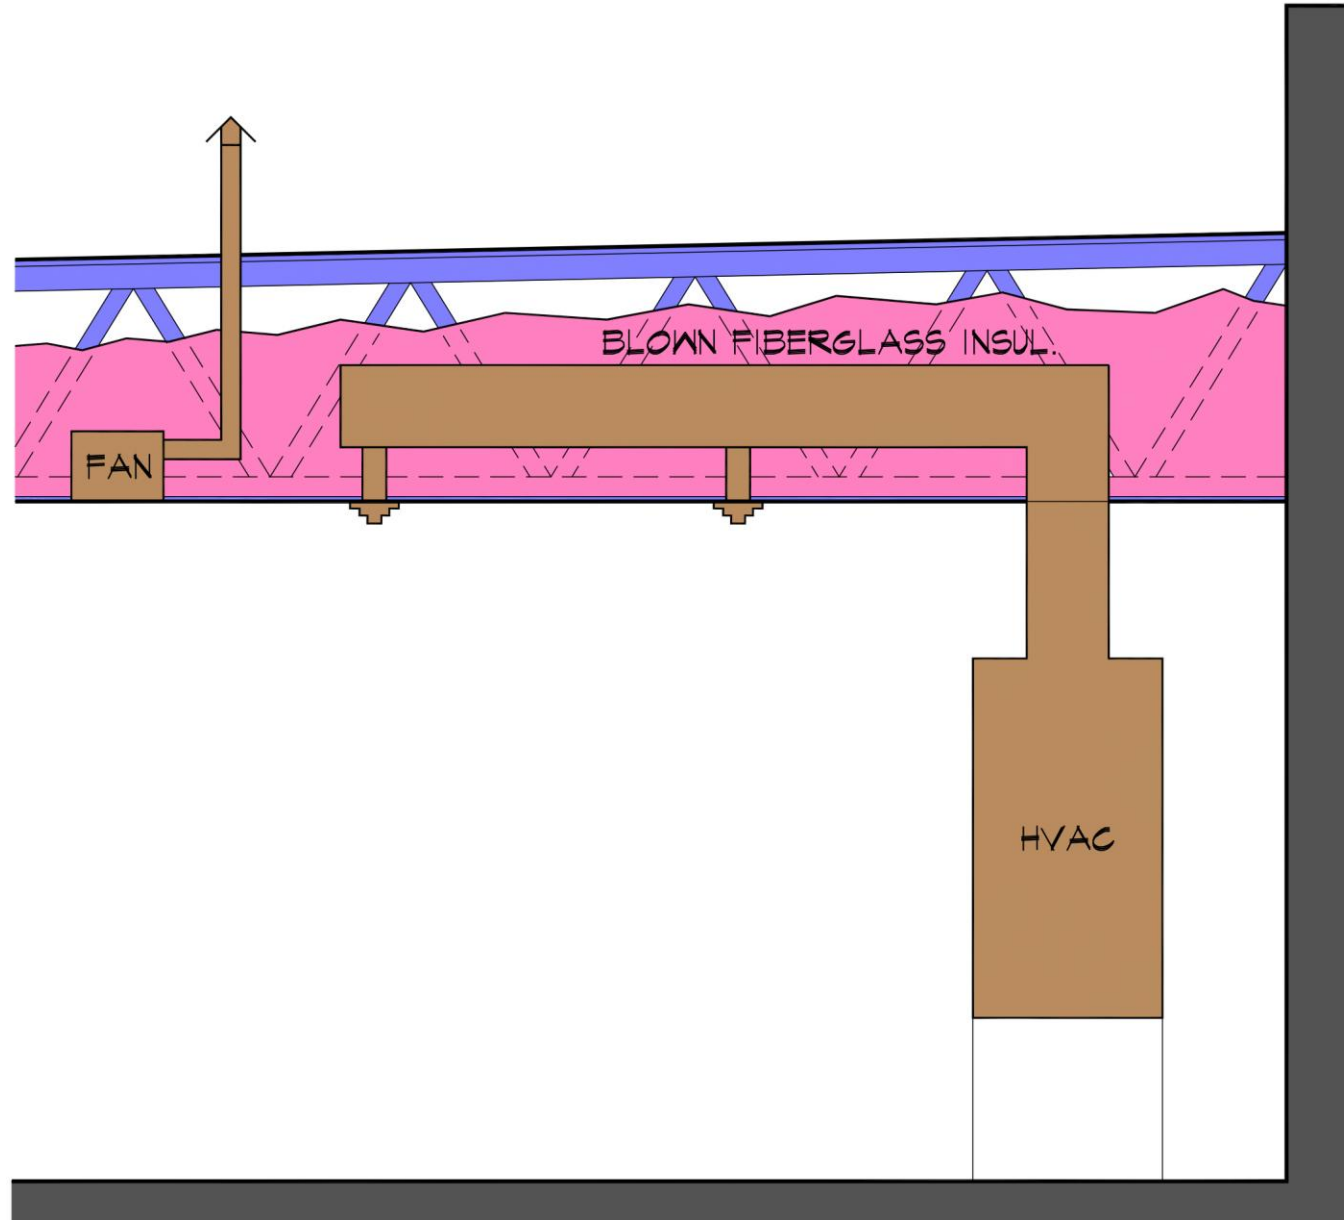
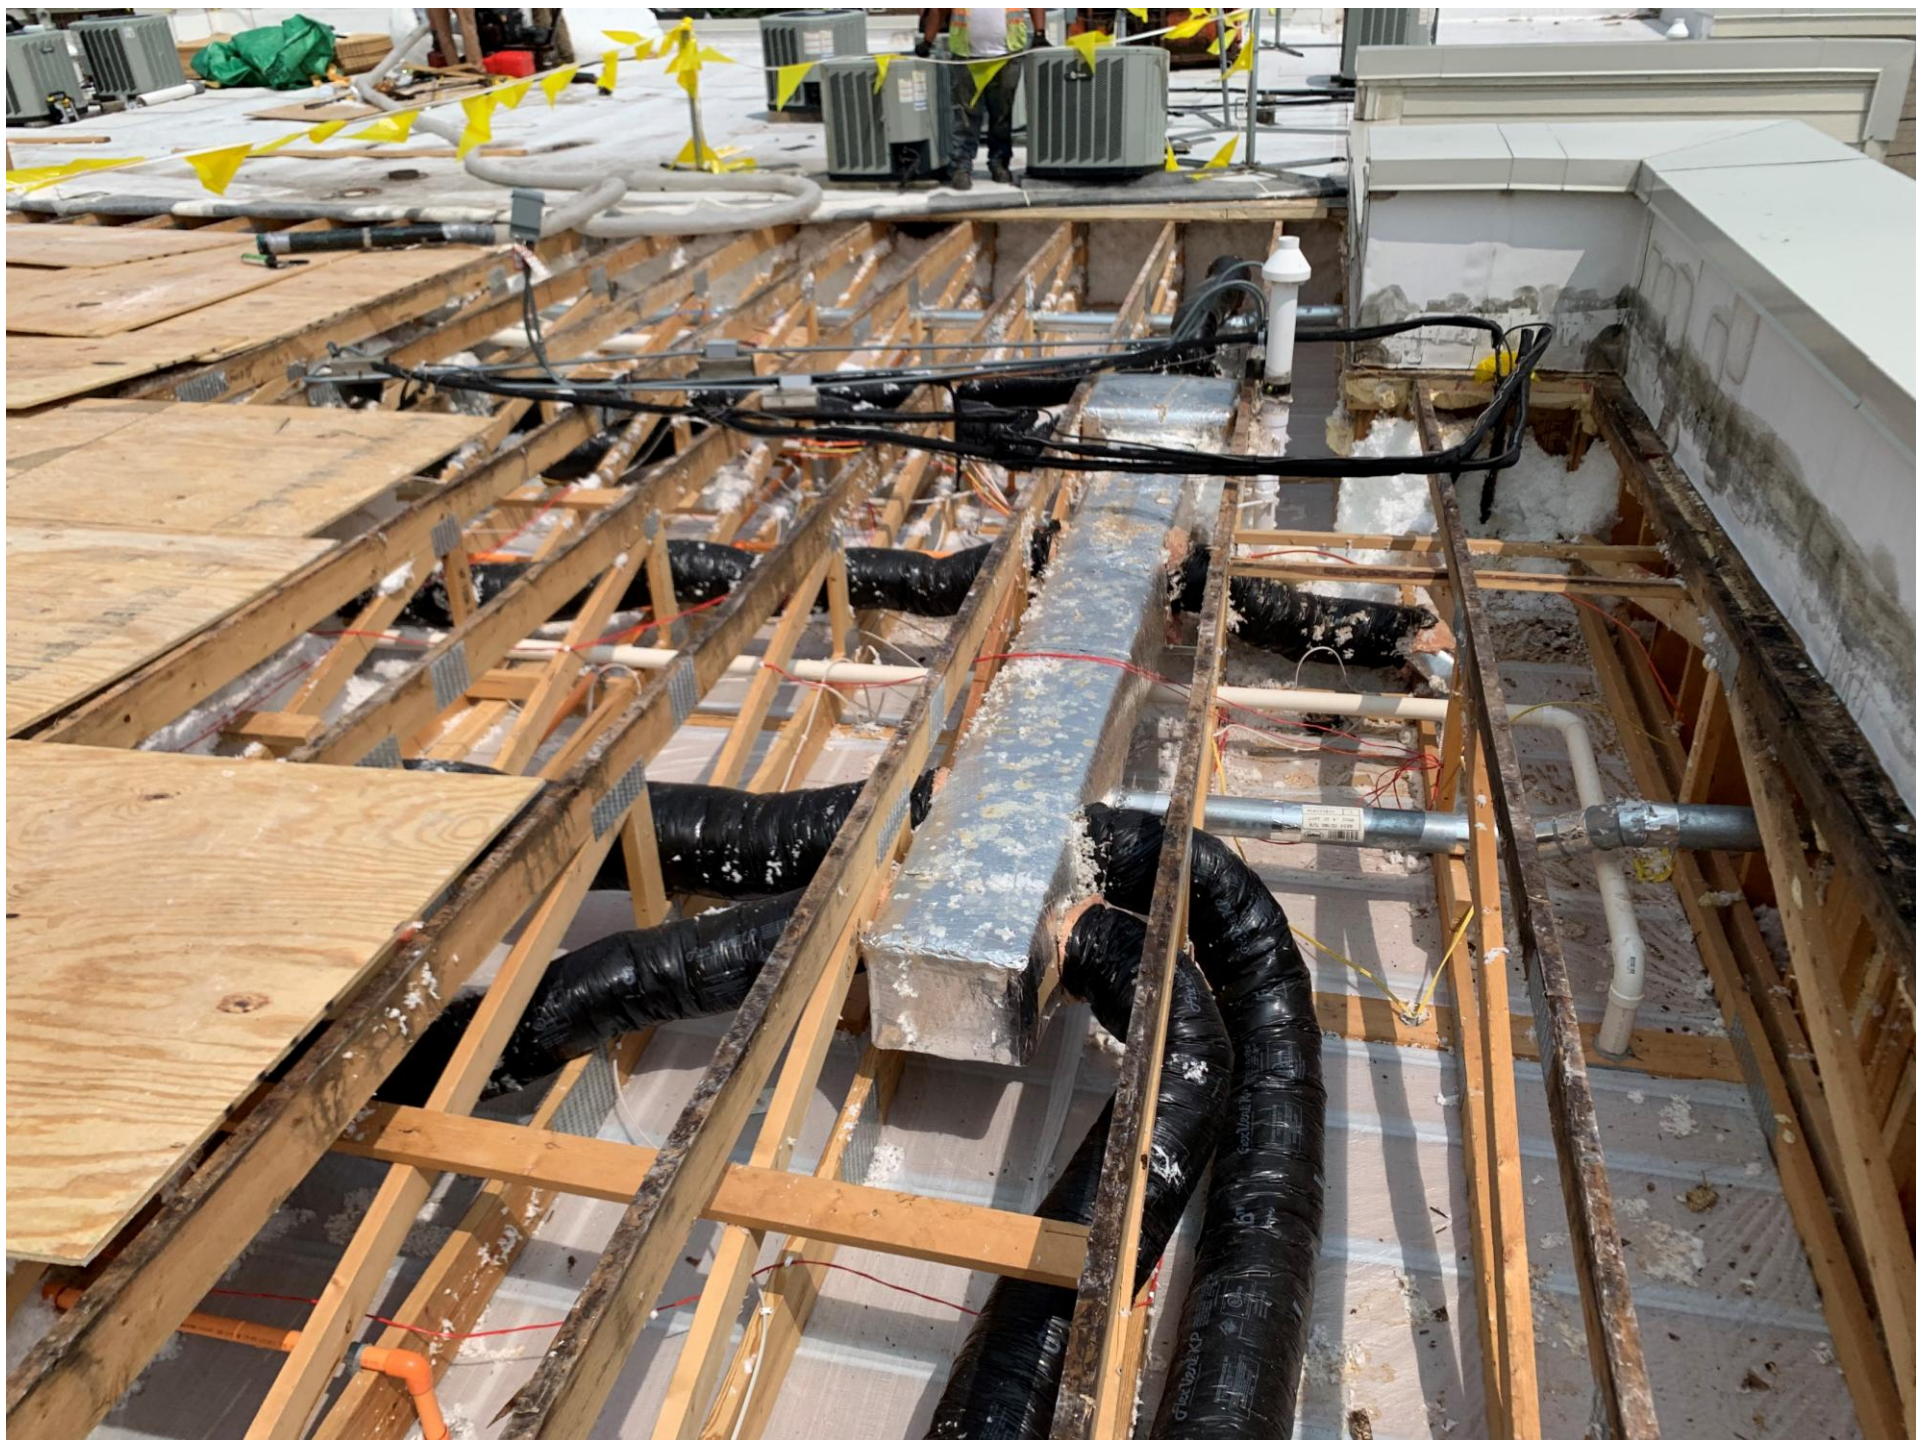
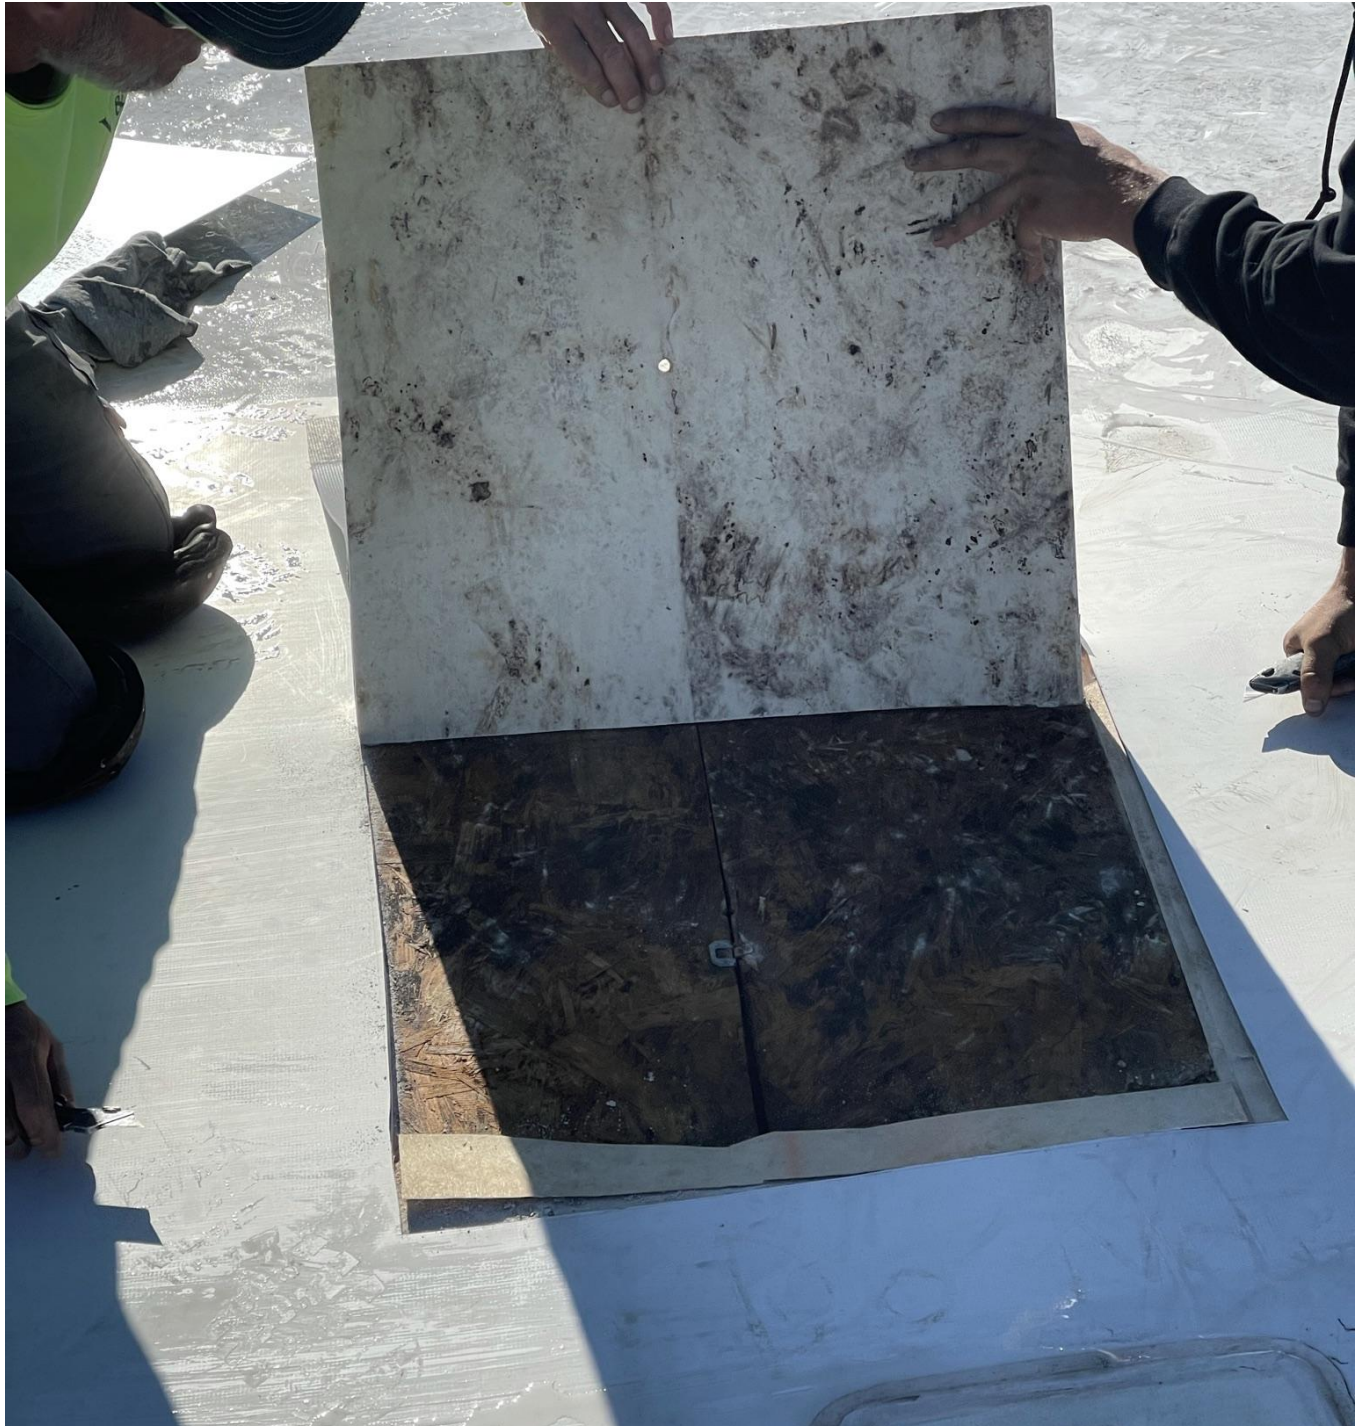
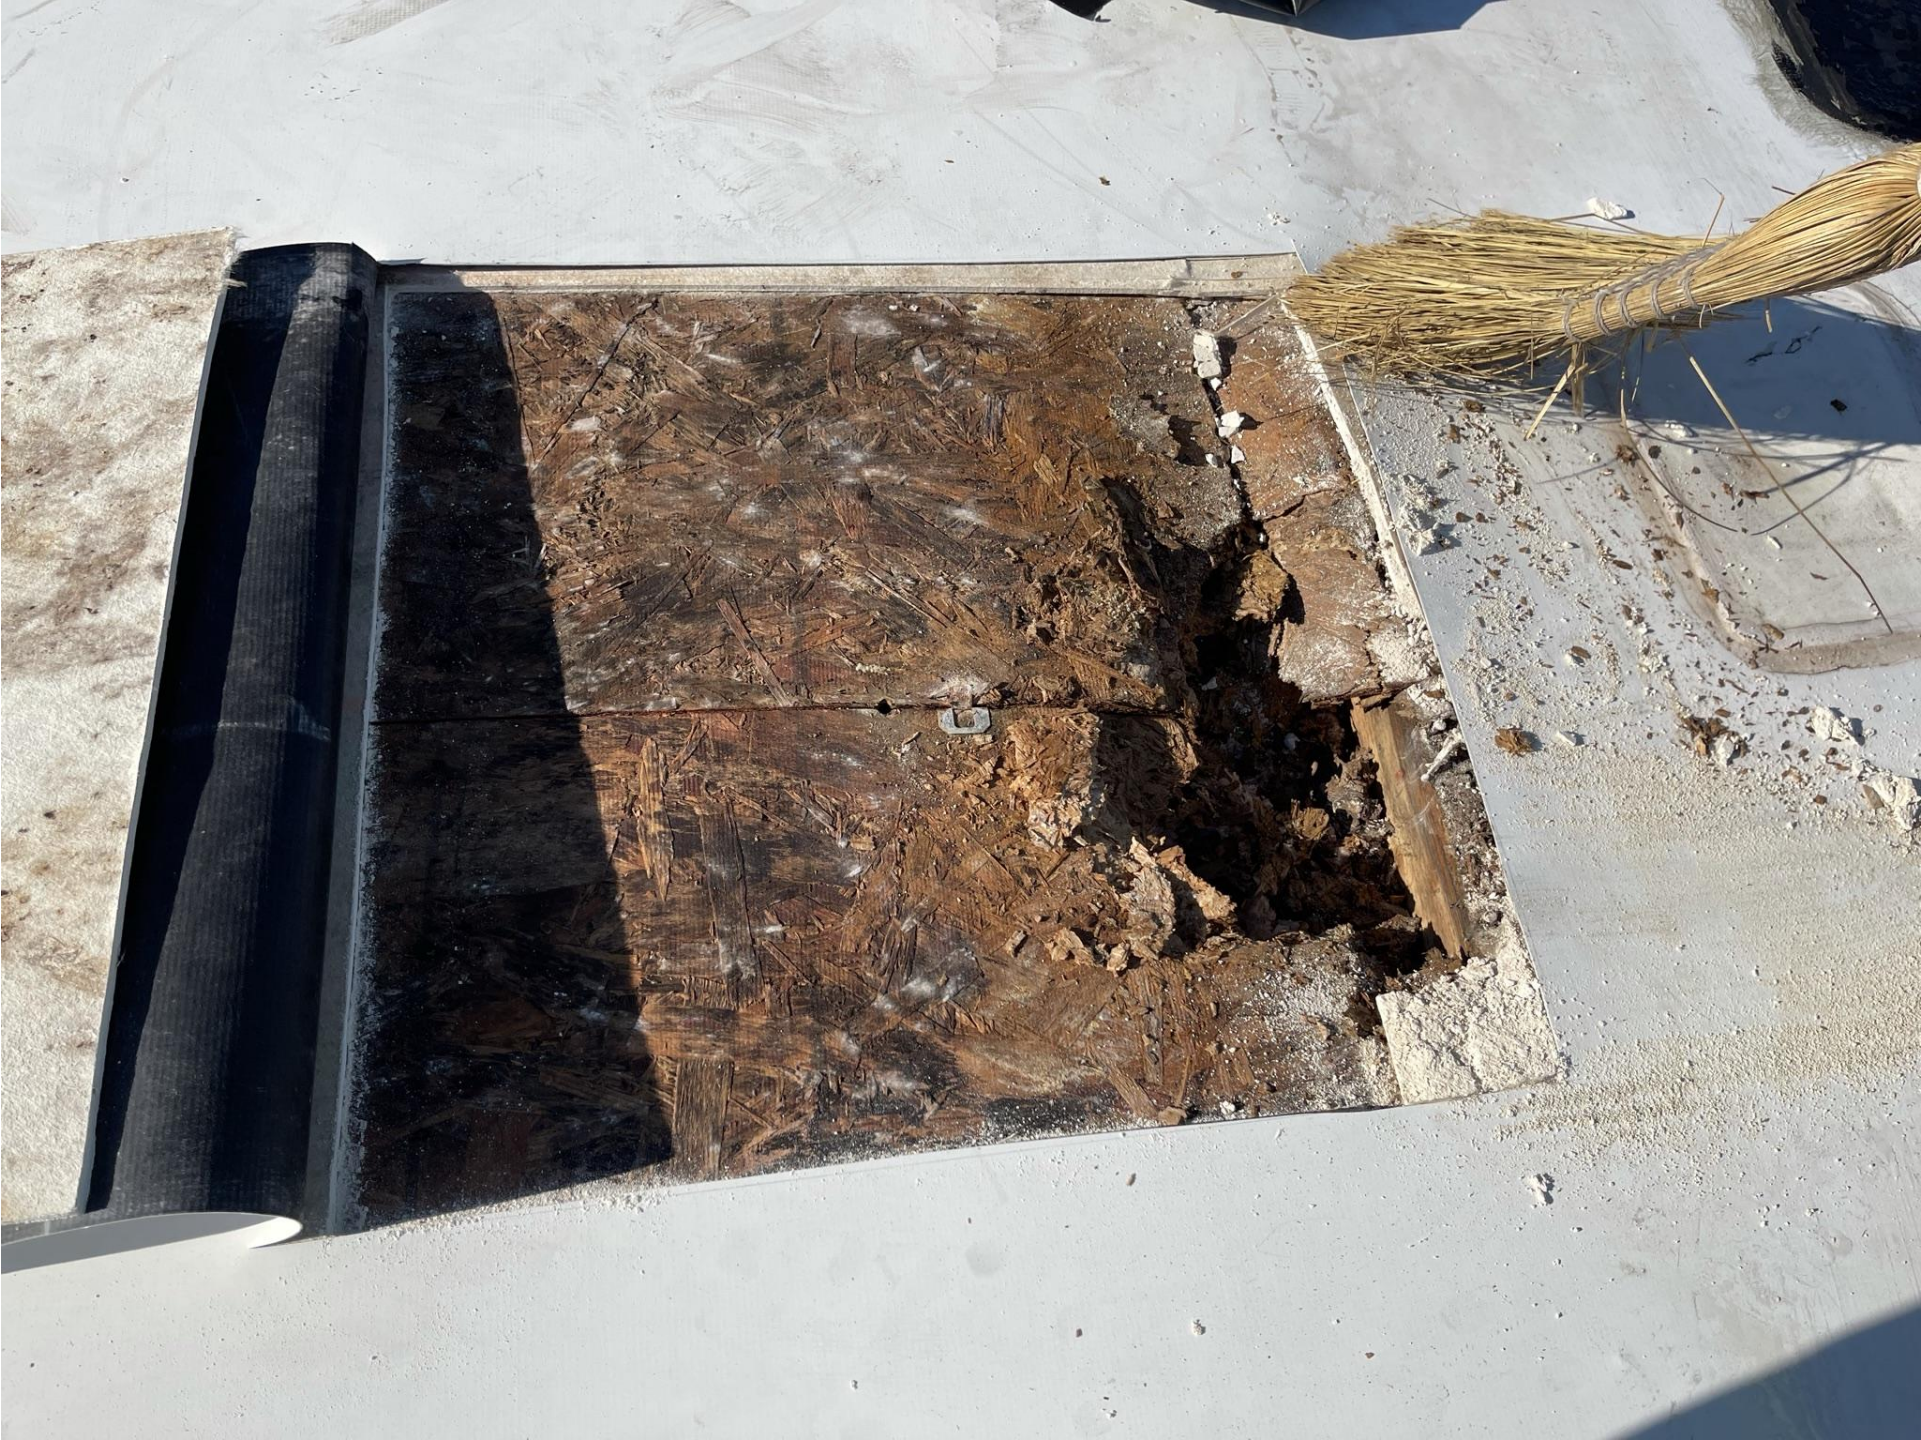
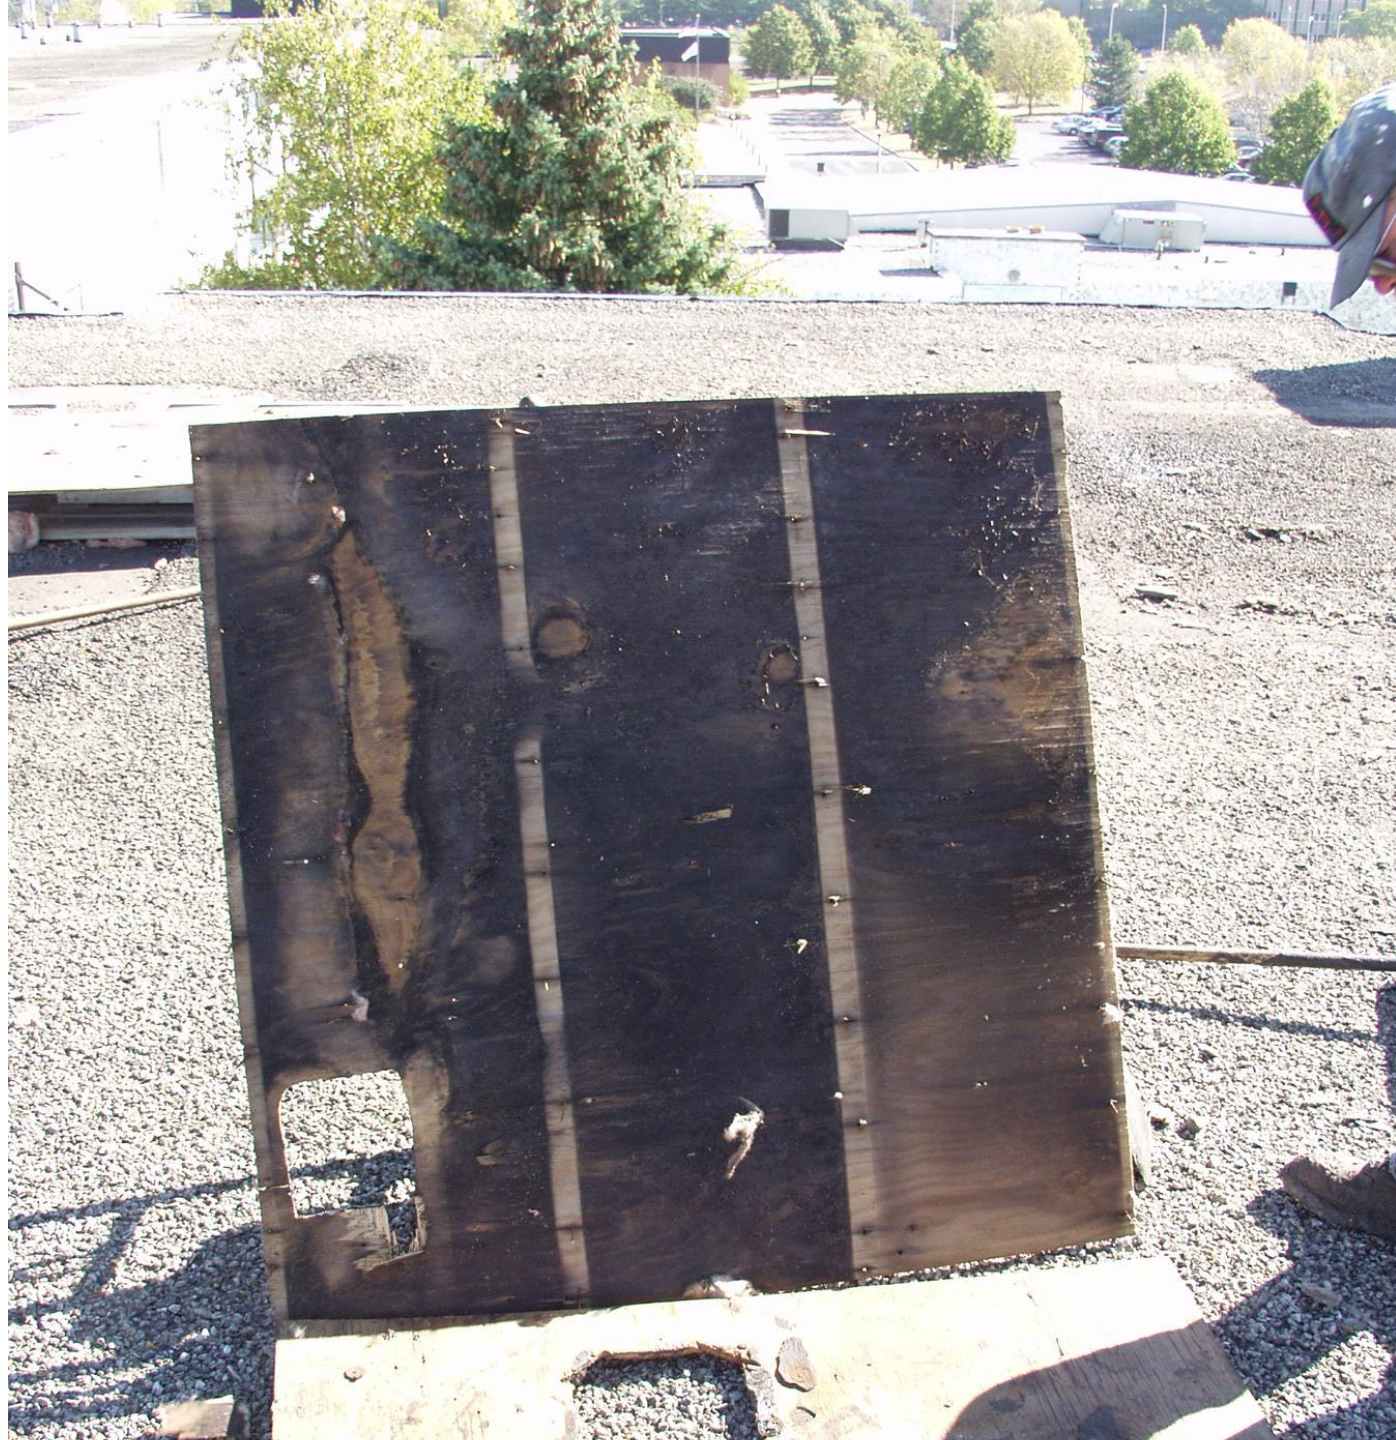
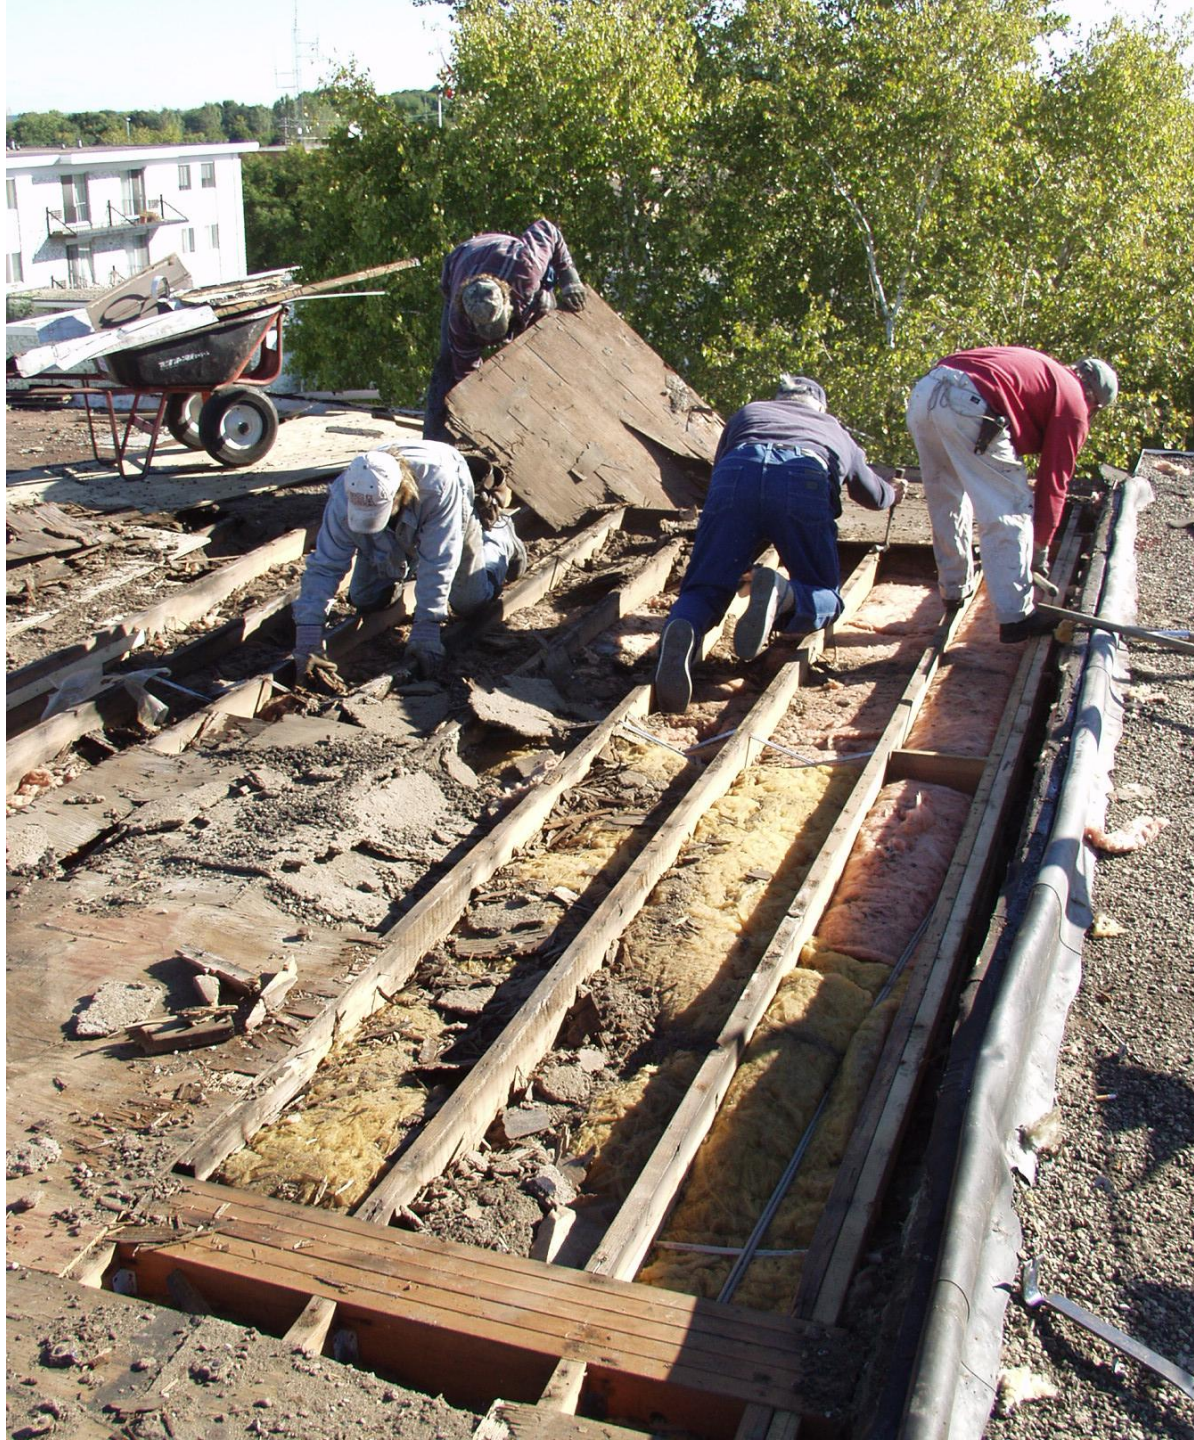
- Problem is air leakage
 - Low voltage systems
 - Light fixtures
 - HVAC ductwork
 - Bathroom fans
 - Dryer vents
- All of these leak air to varying degrees
- Roof deck is almost same temperature as exterior
- Typical indoor air can have dew point temperatures in the 40-50°F range
- Deck condensates and moisture-based damage occurs

- Even when everyone agreed what went wrong, roofer was drug along in legal proceedings
- There have been variations of this scenario
- 99.99% ultimately blamed on Designer of Record's choice for cold roof
- Fix?
 - Repair moisture damage
 - Place insulation above roof deck
 - Keep the roof deck warm and not a condensing surface
 - As little as R-5 to R-10 has been anecdotally shown to prevent the decay
 - Experience shows that code required insulation will protect the roof deck even without sealing and ducts or penetrations
- See *Professional Roofing – Know the Facts*, March 2022 for article

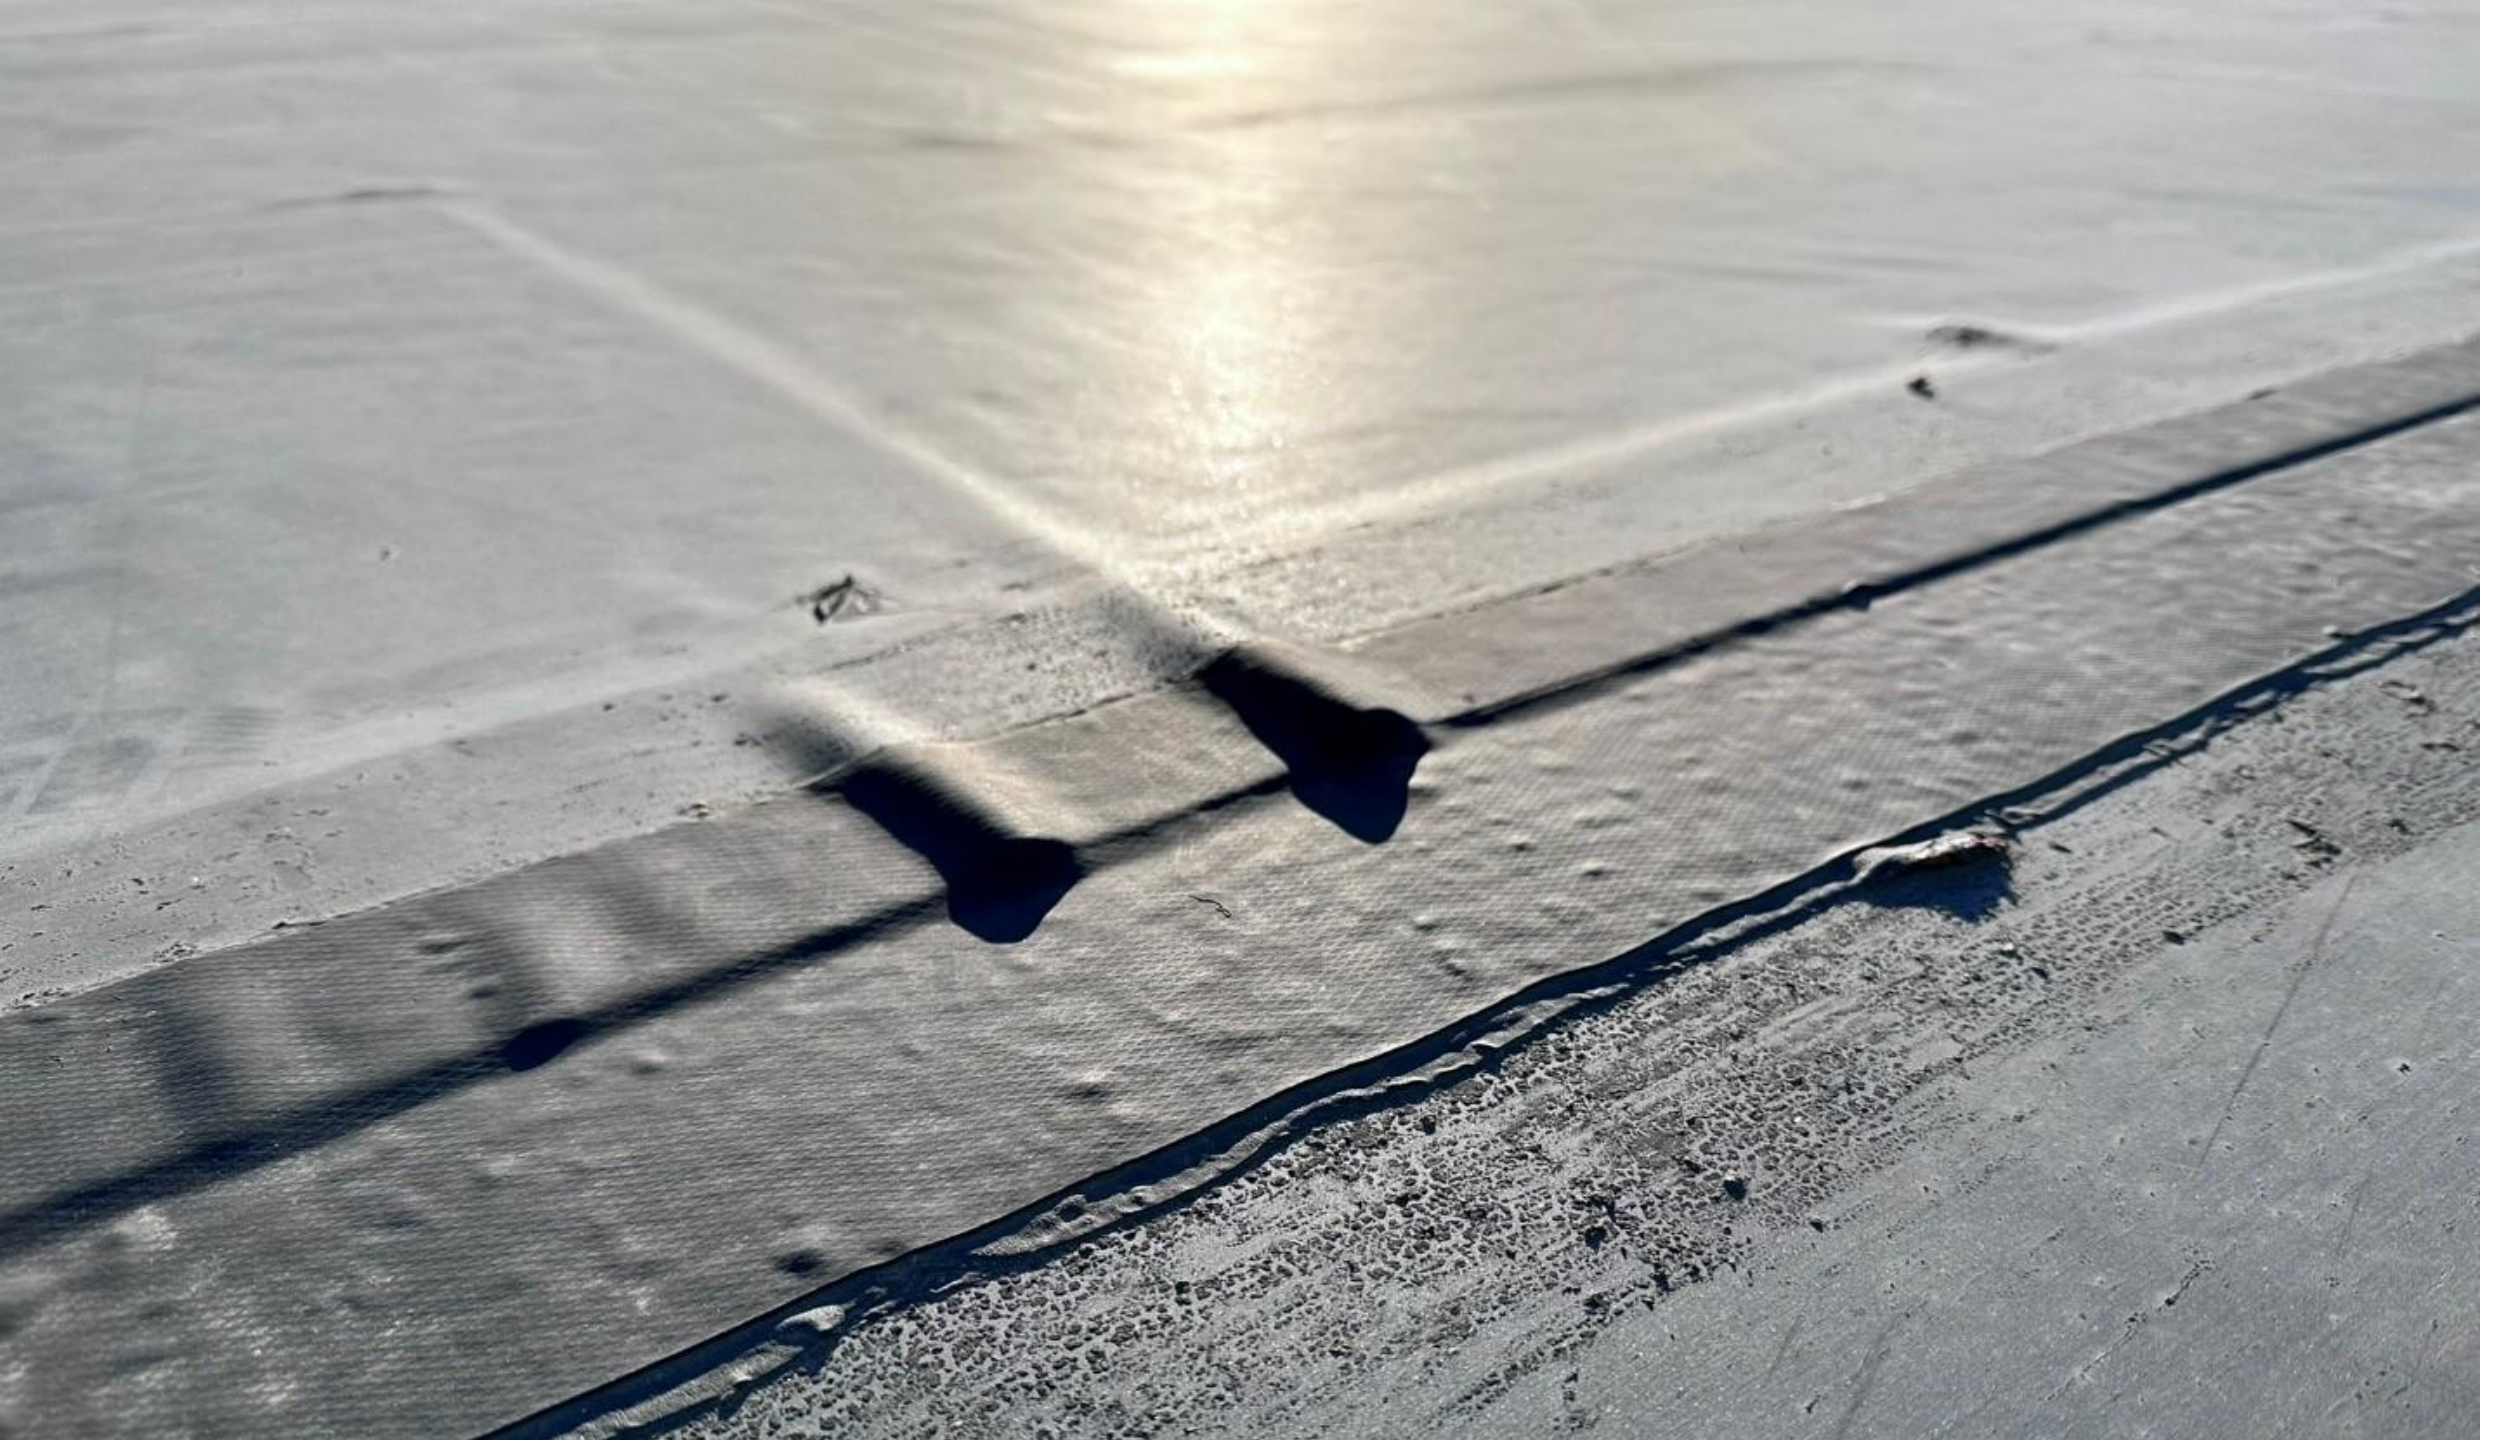
- Self Adhering EPDM
 - Shrinkage
 - Believed to be mechanical not formulation
 - End lap slippage
 - Side lap wrinkles -> fish mouths
 - One product, one manufacturer

- SA EPDM
 - Corrective action from manufacturer has been to apply cover tape to all laps
 - Appears to be sufficient correction
 - This is typically done for extended warranties, and this tends to quell fears of owners
- TPO
 - Single interesting case
 - East coast contractor had project where the TPO was cratering at laps
 - Small pieces of membrane were “popping off” during welding
 - Remember this is 800-1000°F welding temperatures

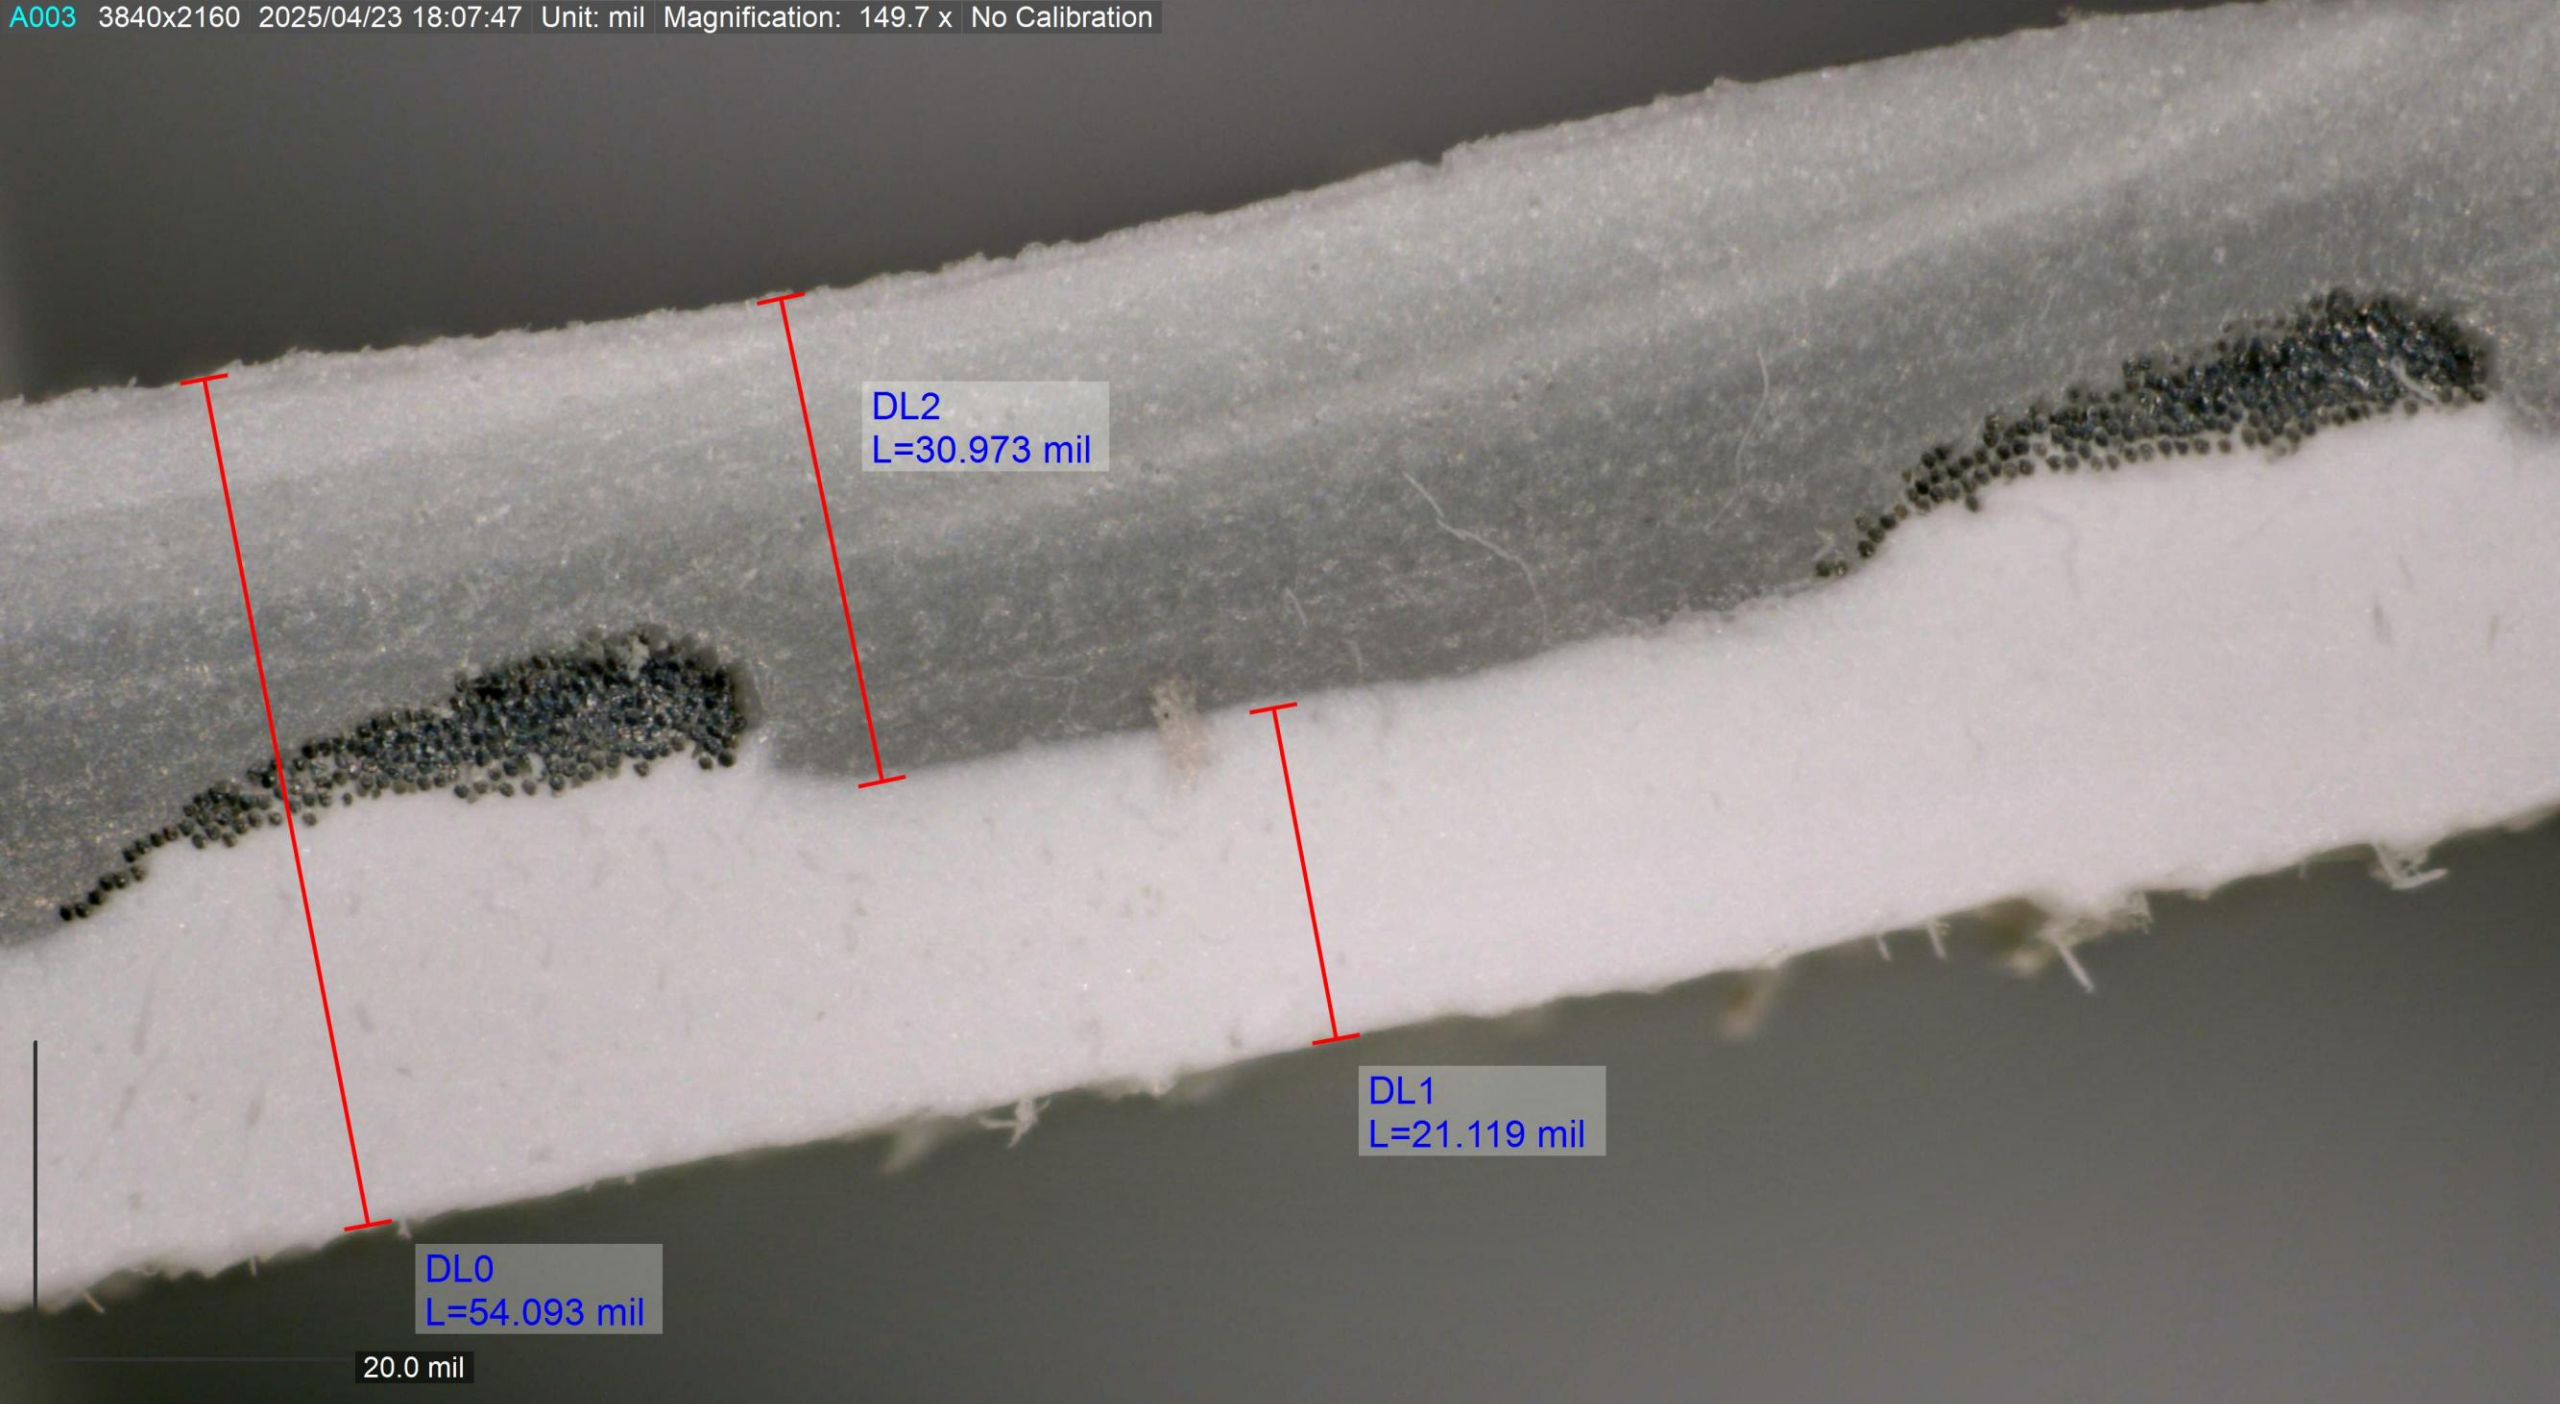
- TPO
 - Speculated to be too high moisture content in TPO ingredient
 - Magnesium hydroxide (fire retardant) was speculated to have been received and sent to line with high moisture
 - Hard to prove after the fact
 - Ultimate fix would have been full sheet replacement
 - Owner accepted a coating
- Moral is even with mature product line we can find material or production issues that slip out the door
