January 14-16, 2026
42nd CRCA Trade Show & Seminars

I Wouldn't Do That If I Was You...

Current Technical Roofing Issues From Field Forensics

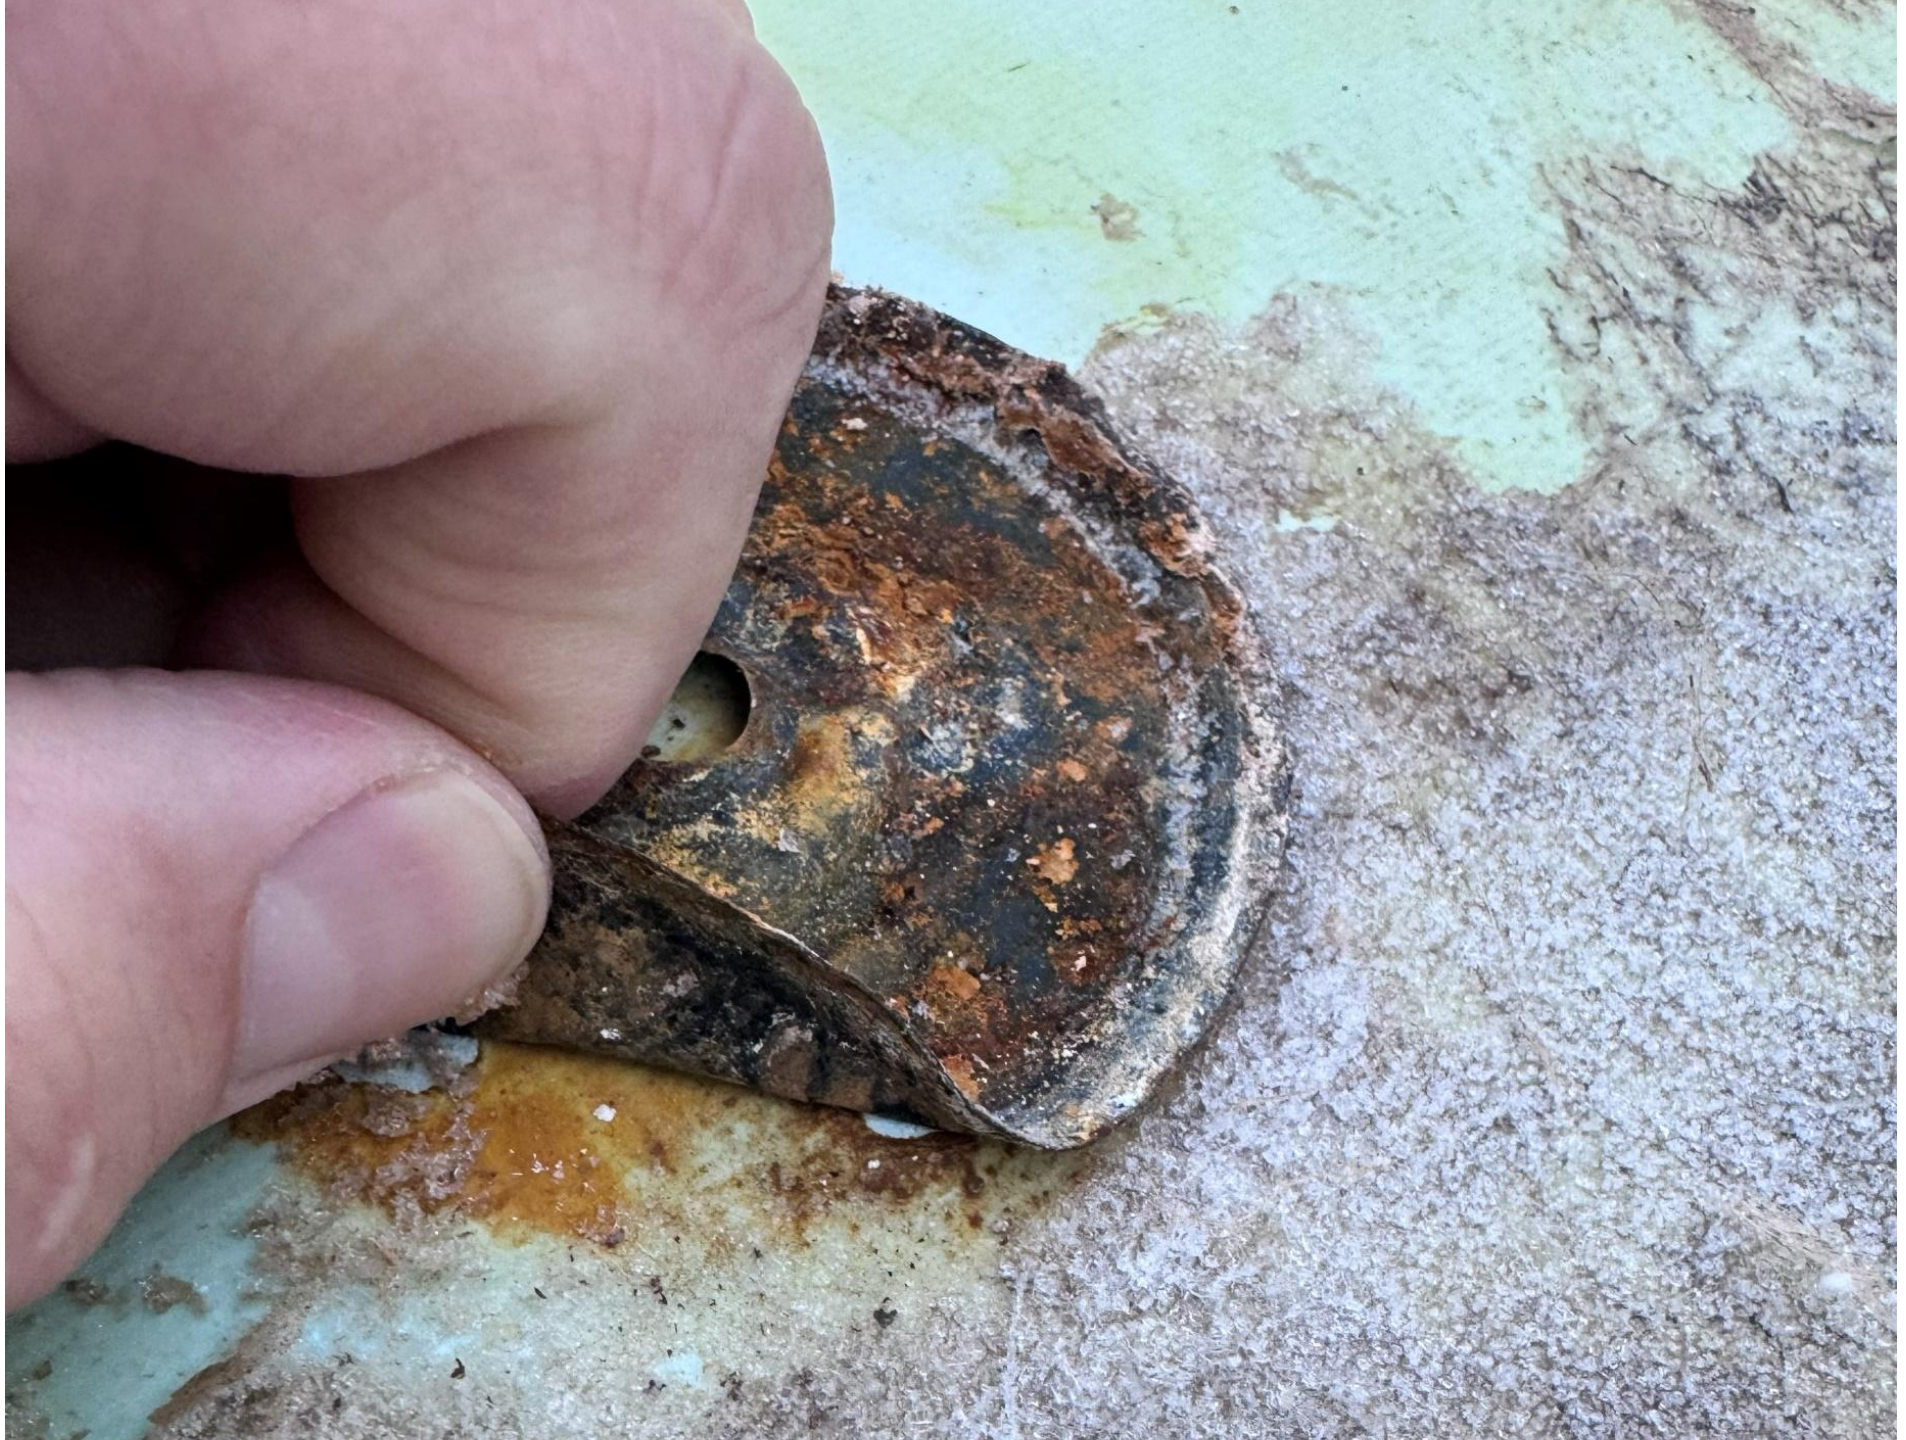
- Additionally, we have seen pictures of fractures in the metal of new plates at fastener opening.
 - Metallurgical or die issue?
- Variation seen in saturated roof systems where black coating on plates will detach from metal plate
 - Membrane left unattached

- Best advice
 - Photograph and save lot numbers on plate boxes
 - Save test welds for extended period
 - Inform field staff not to ignore issues and just “reweld” again and again

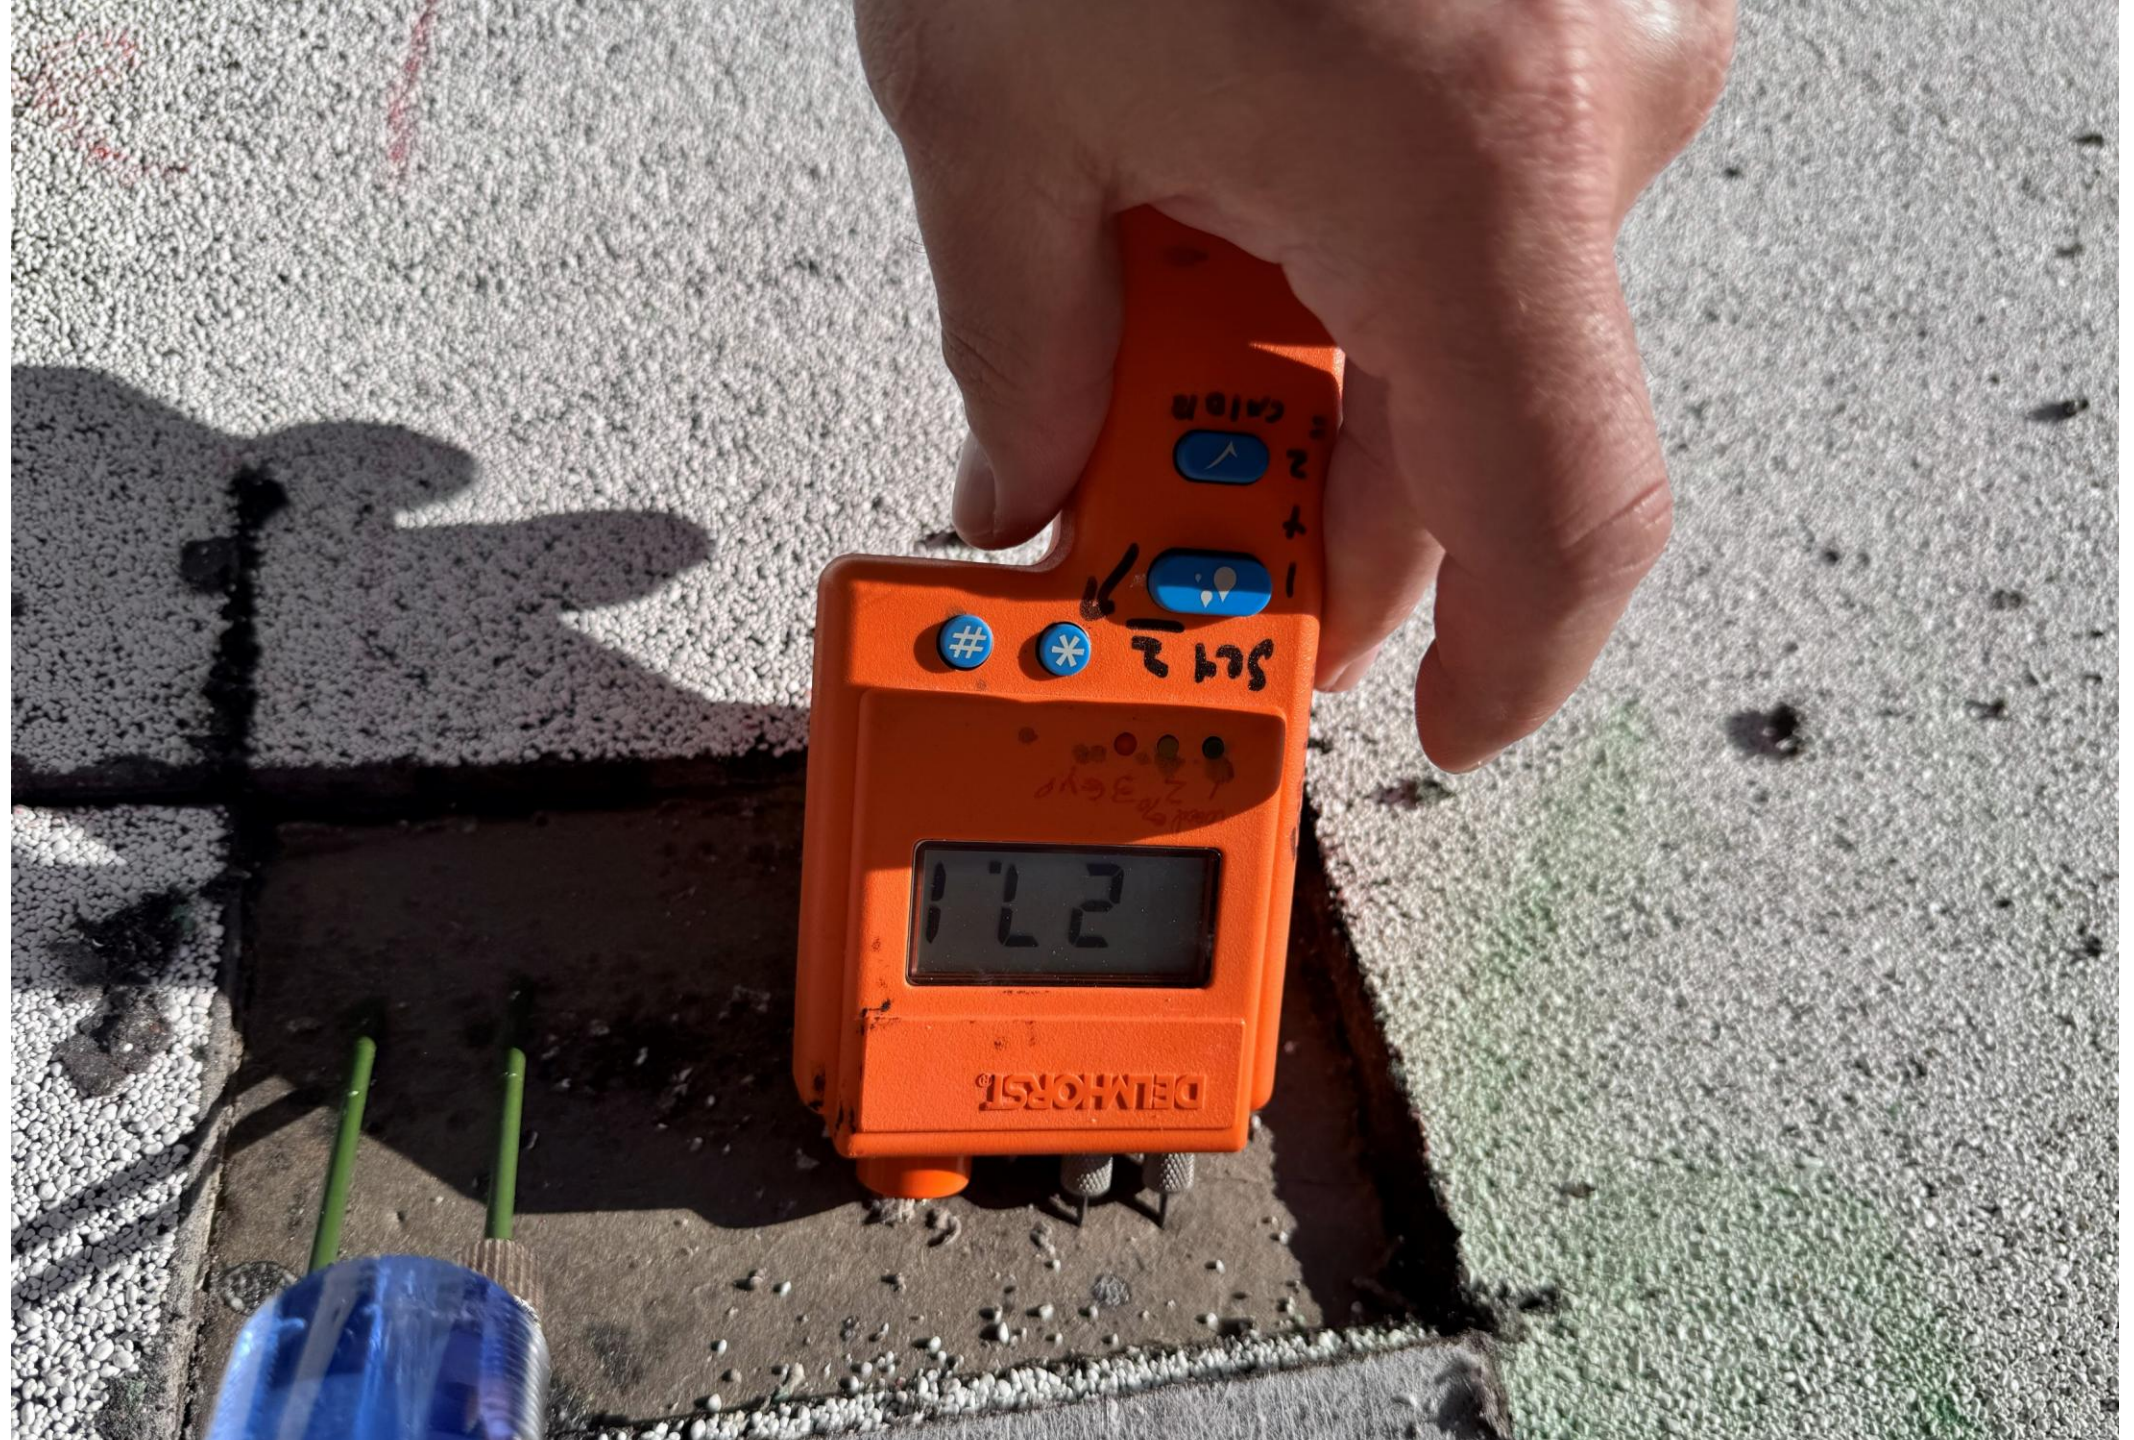
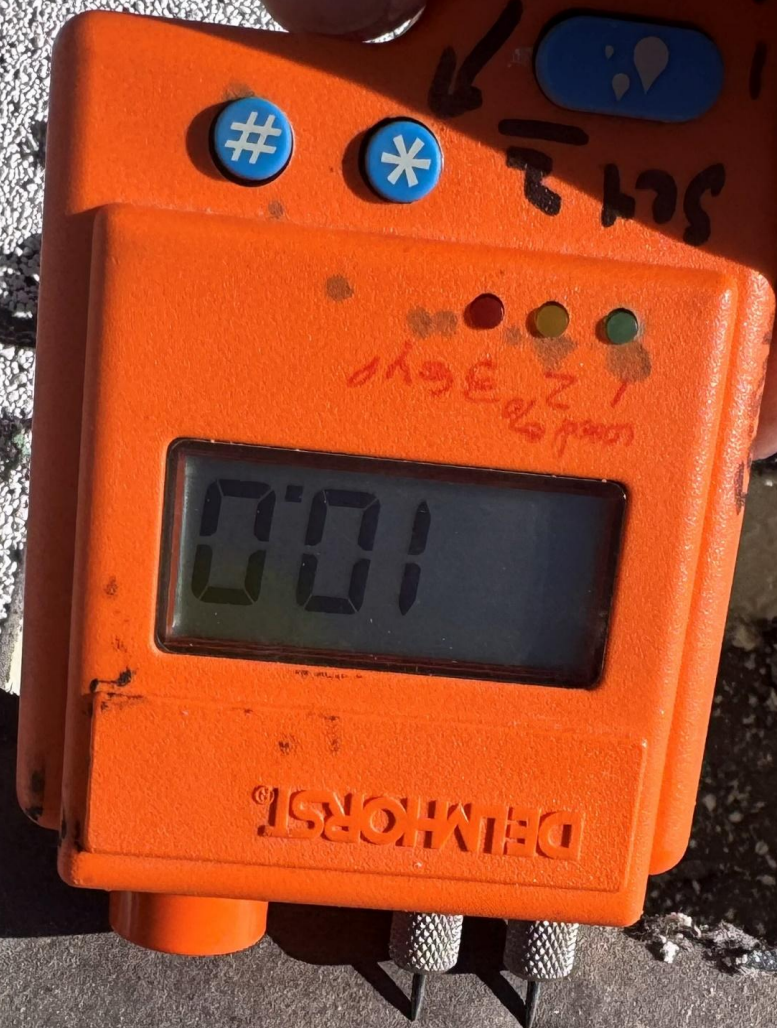
- Result of heavy vapor retarders combined with thick insulation and coverboard system
- Any free moisture in insulation and coverboard is now stuck between membrane and vapor retarder
- Physically a minor amount of moisture
- But enough to trigger moisture meters
- Open the roof to dry air and moisture leaves in minutes

- Store materials as close to manufacturers instructions as possible
- Understand that a moisture meter is not calibrated to that material (typically)
 - So, use as an indicator but don't believe the numbers
- Do not store materials over surfaces that can readily emit moisture
 - Grass, gravel, sand
 - Avoid poly tarps tight to ground (greenhouse)

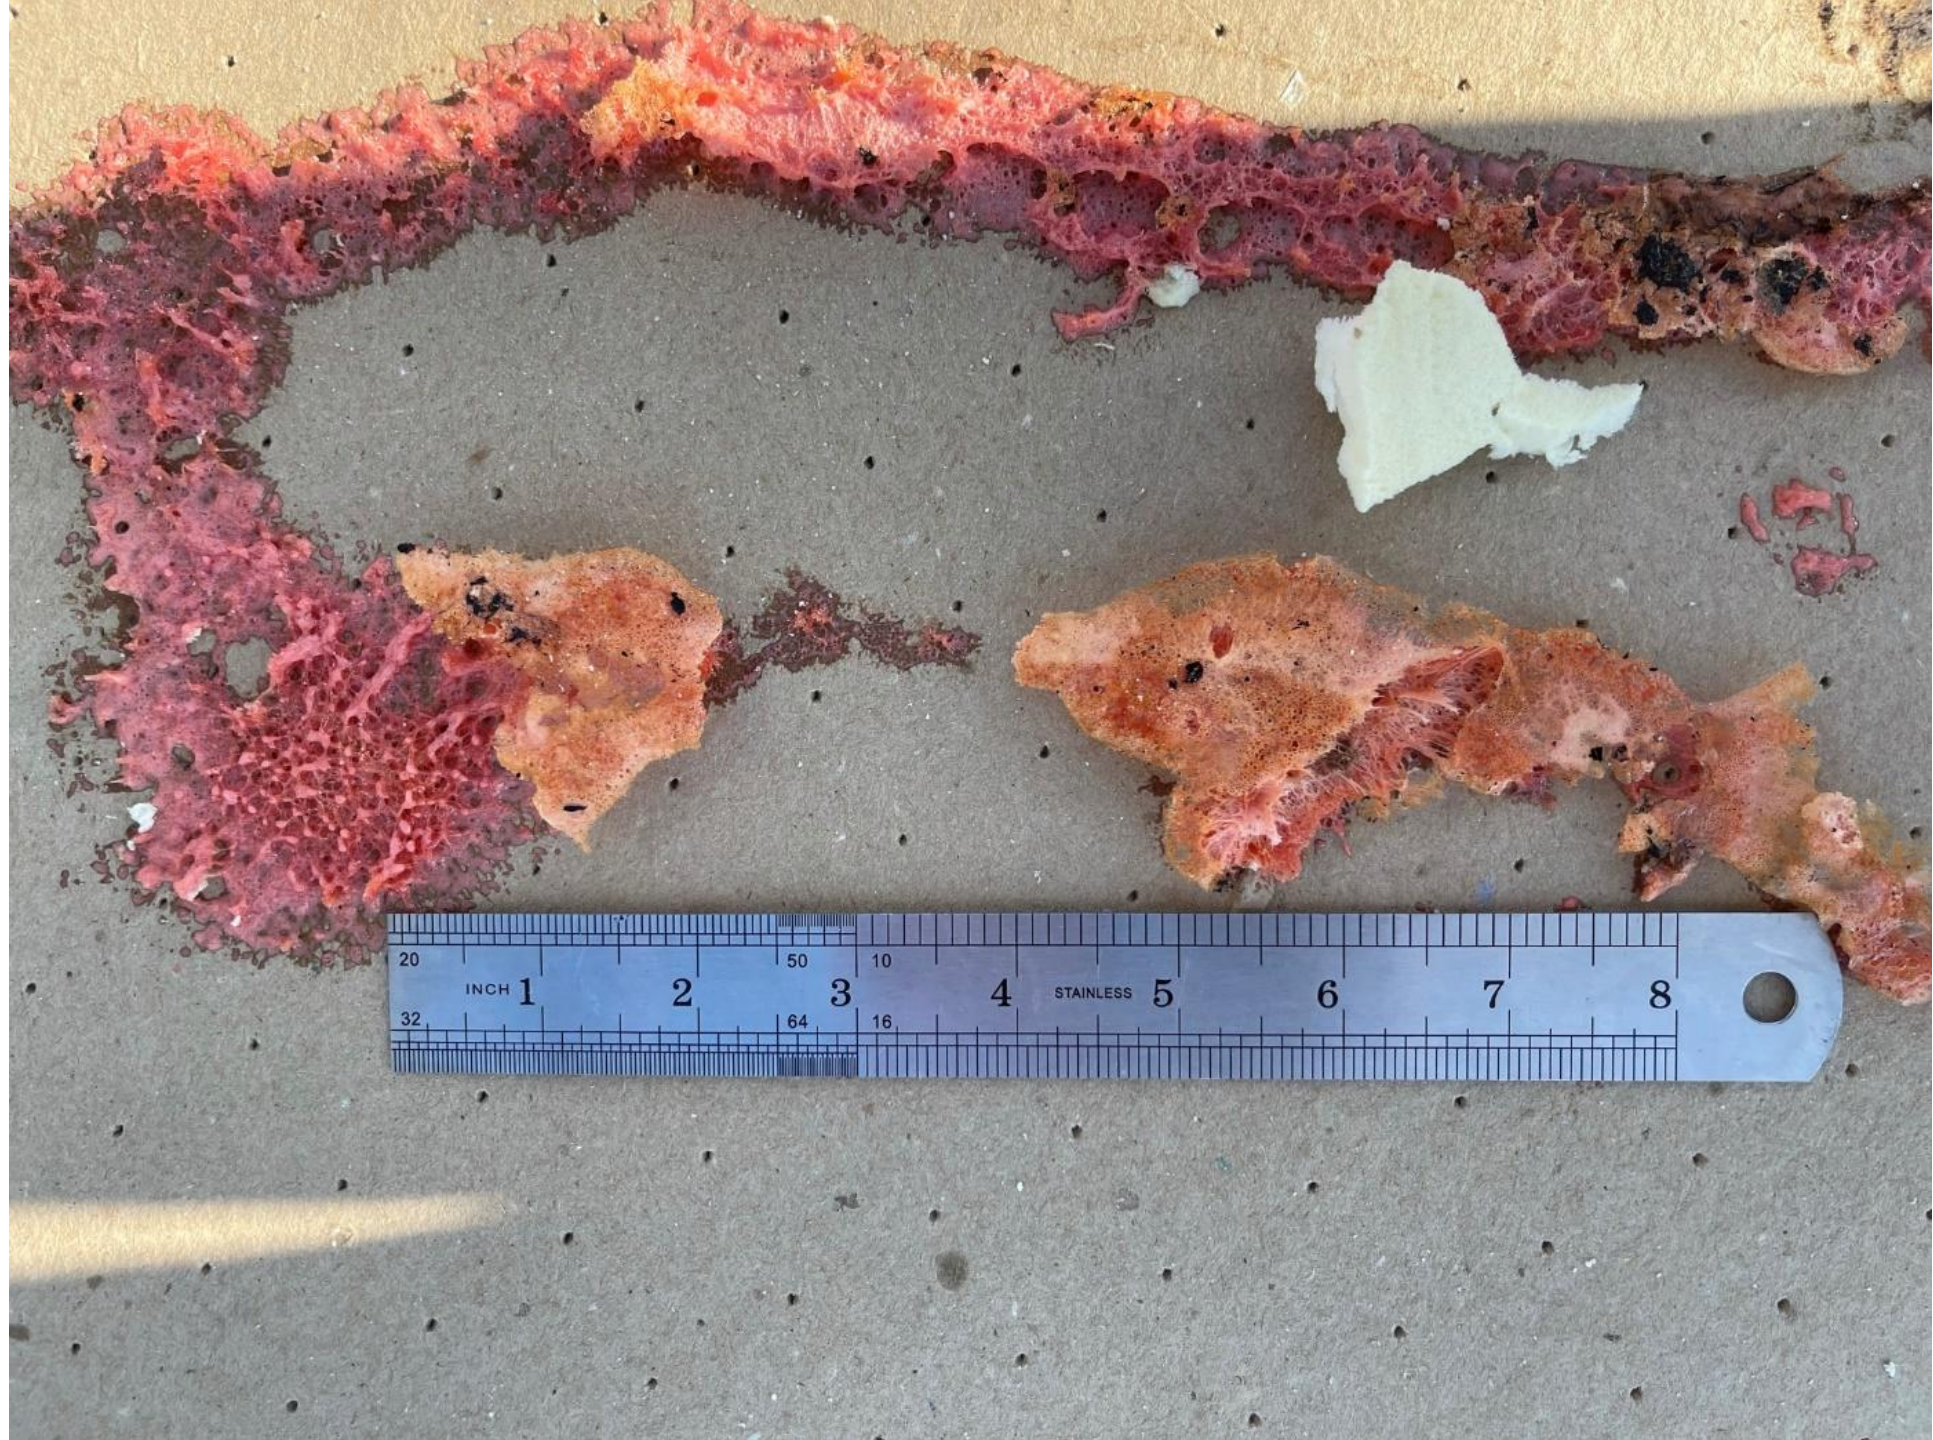
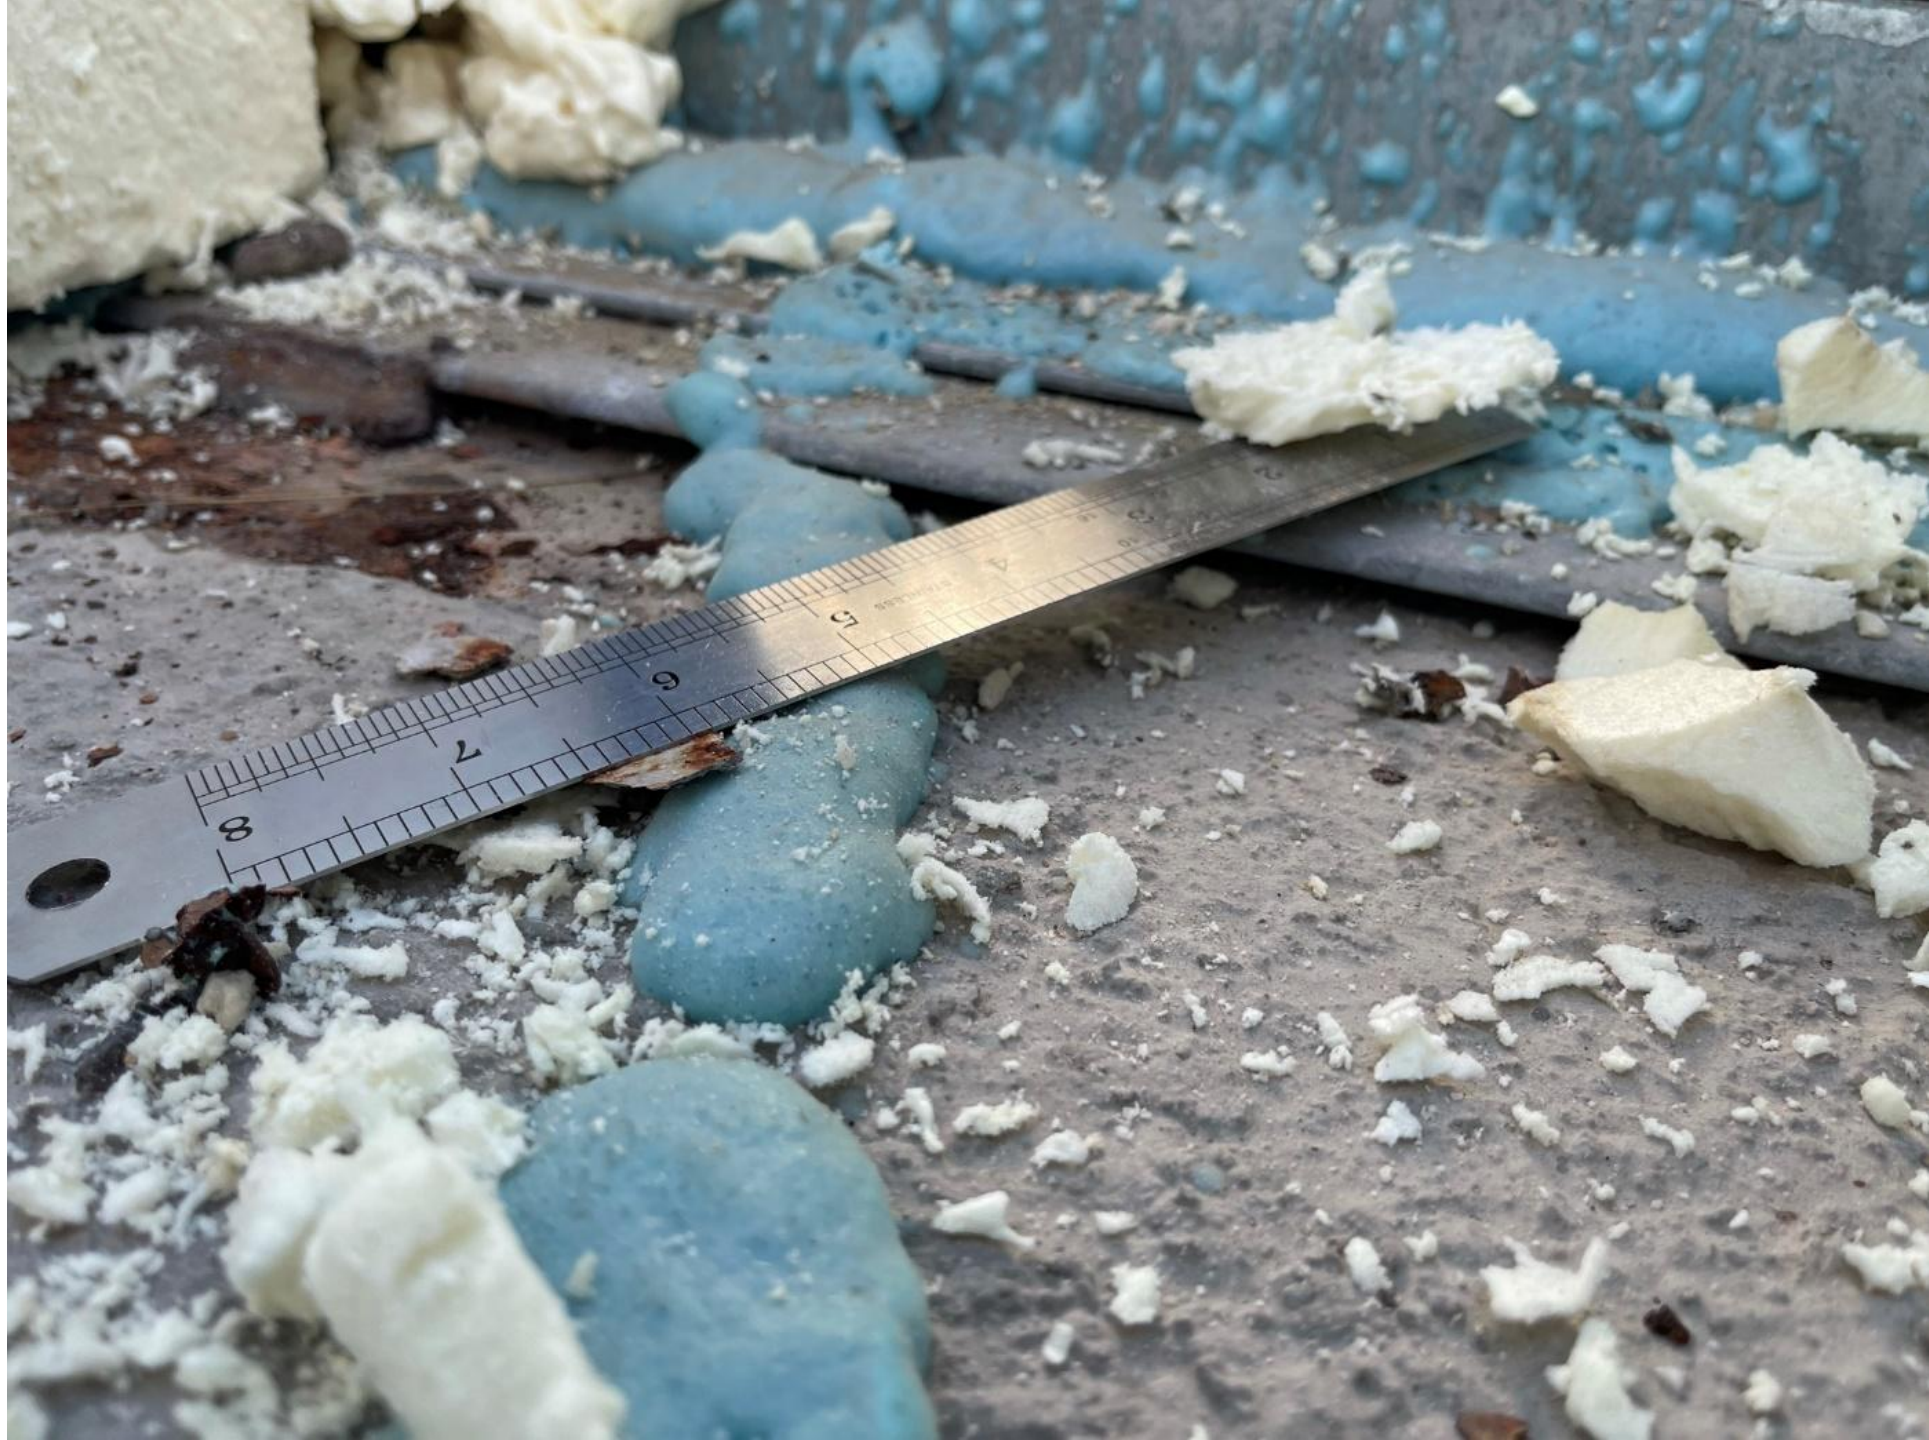
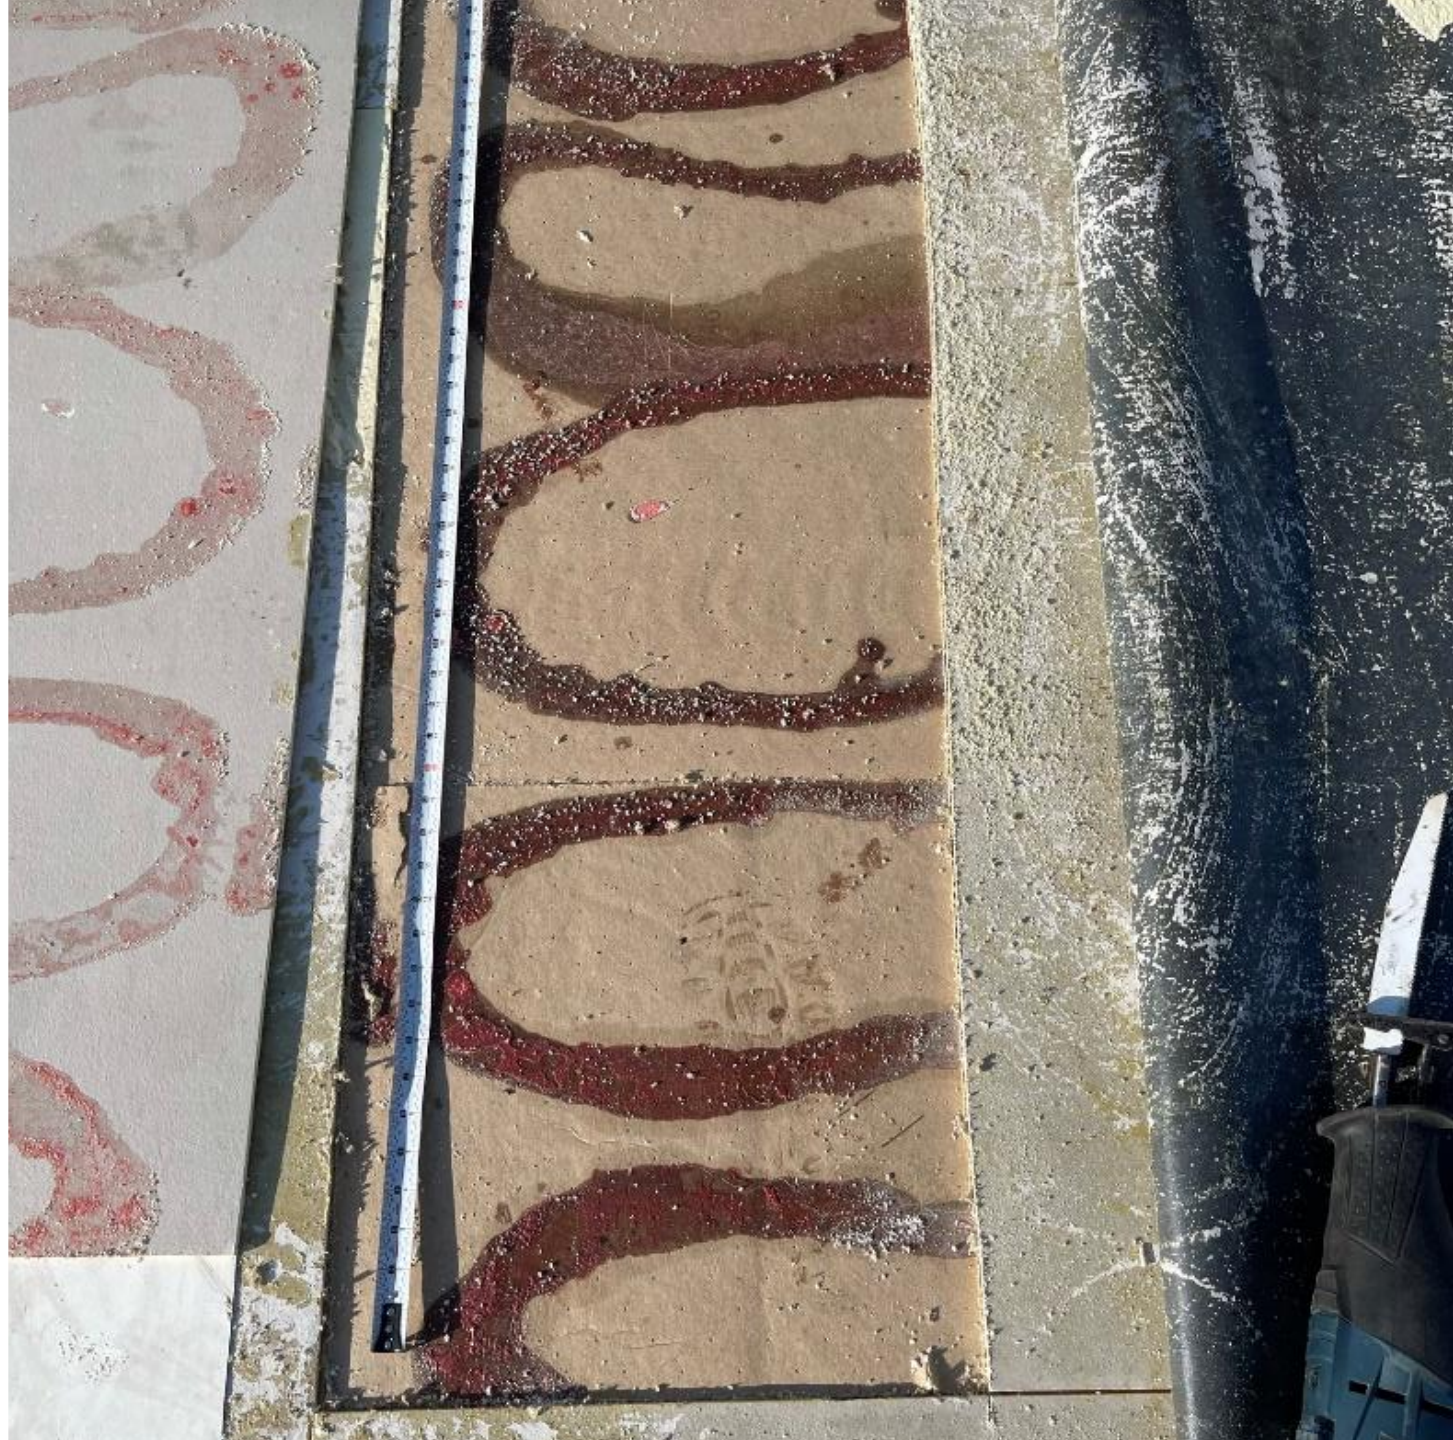
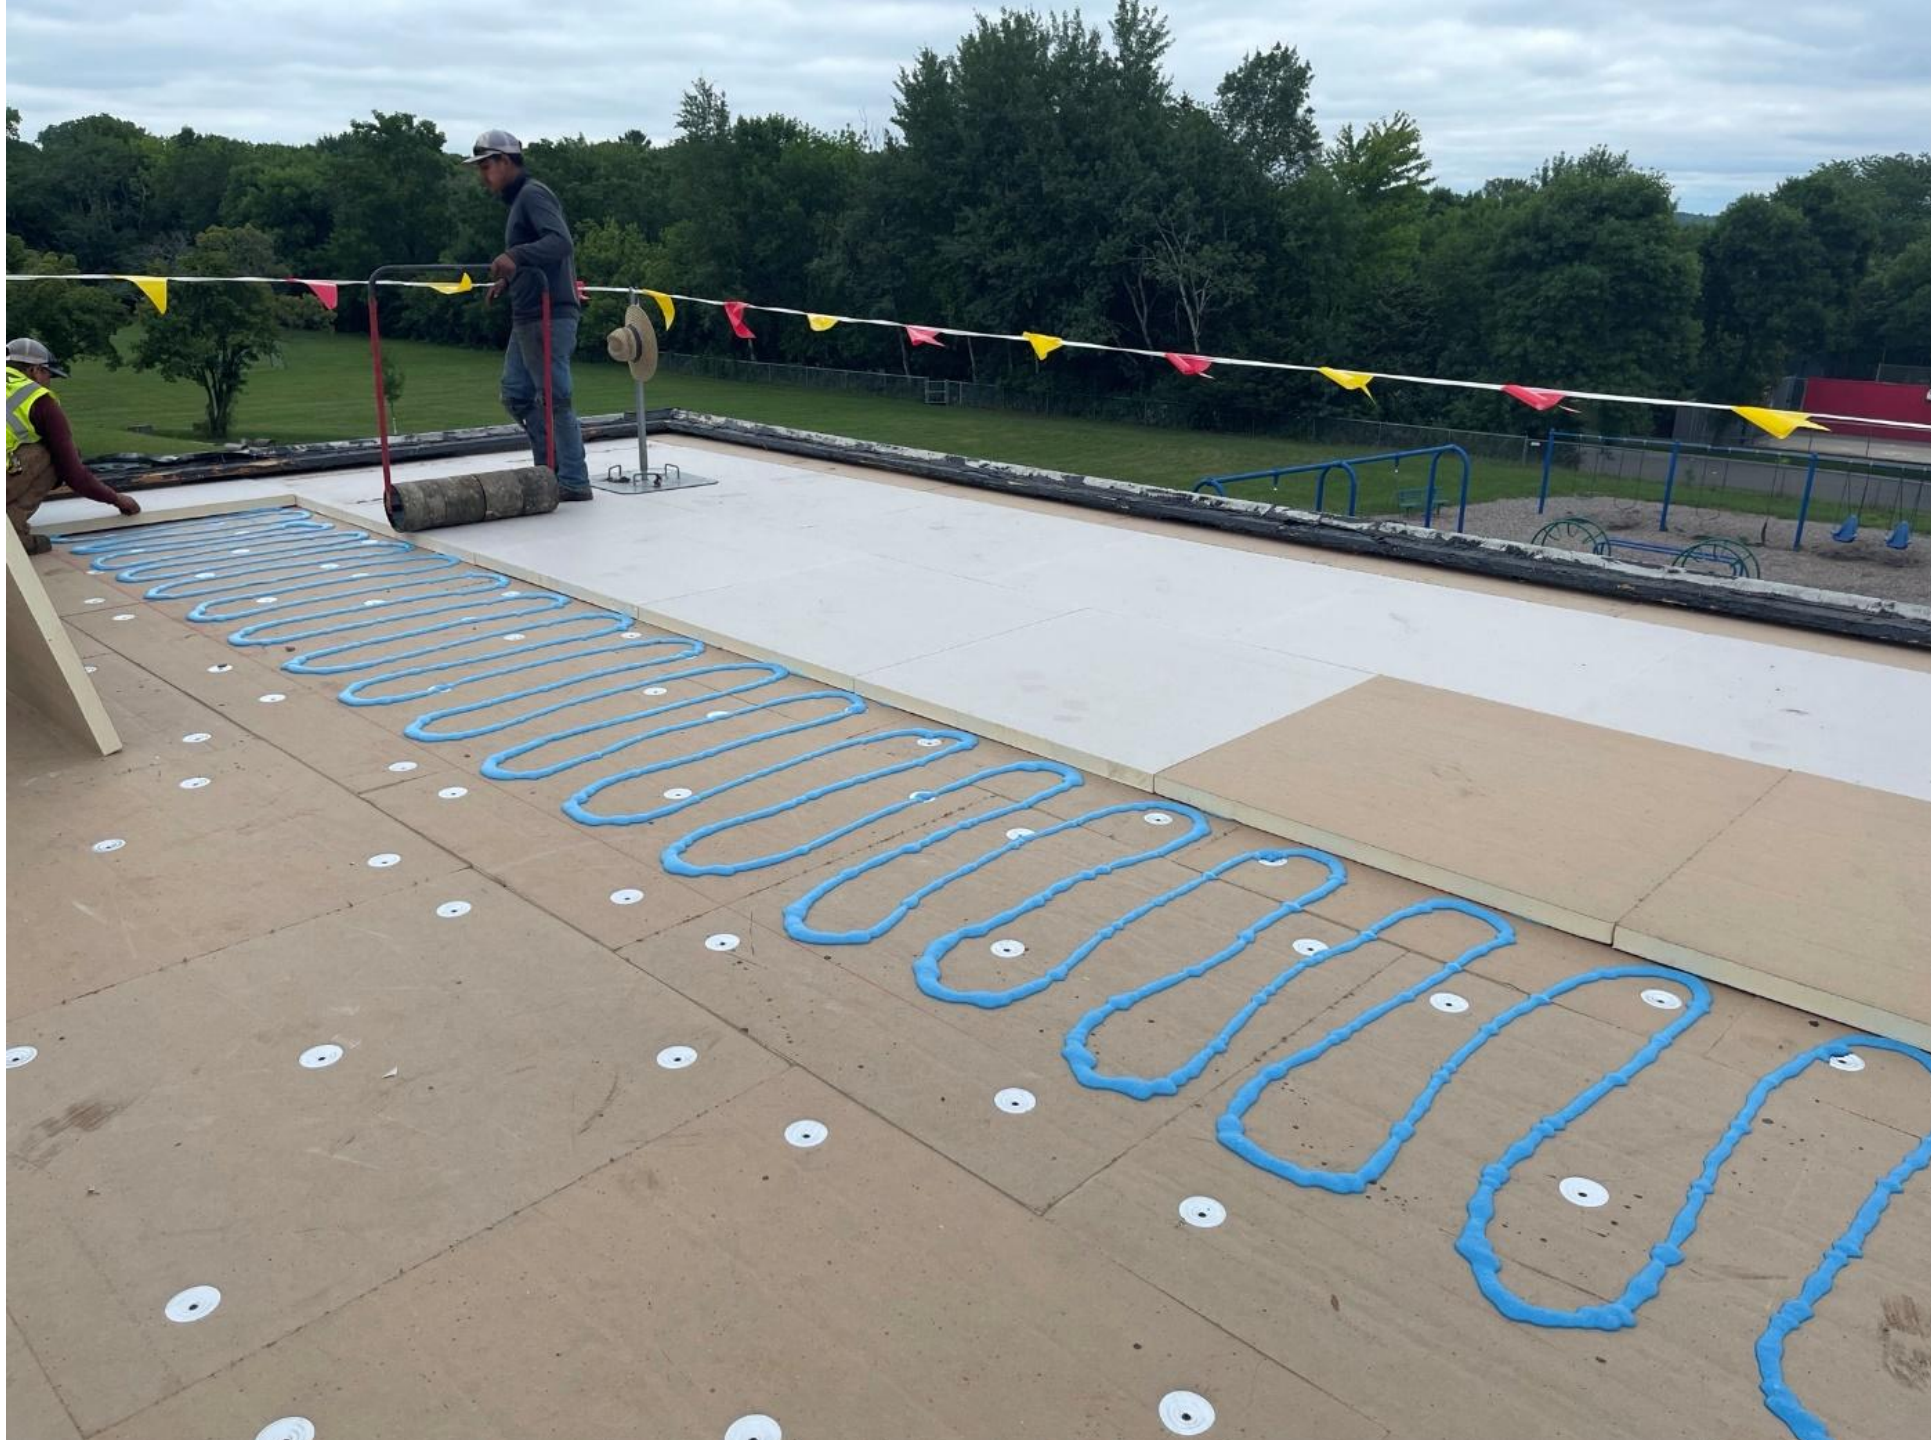
- Discussed at CRCA 2024
- As manufactured and mixed Part A + Part B 1:1 ratio all is well
 - Very strong bond
- Problem has been field mixing and application
 - Temperature
 - Equipment issues (off ratio)
 - Foam ribbon spacings

- Problems
 - Off Ratio foam – equipment issue
 - Ribbon spacing – labor issue
 - Unreacted foam – mixing issue or materials
- Suggestions
 - Invest in foam carts with sensors for pressure (alarms)
 - We used kettles and one worker responsible for kettle, time for this again
 - Clean out old foam in warehouse
 - Asphalt used to be our magic sauce to make roofs work, foam is the secret sauce now, treat it as such.

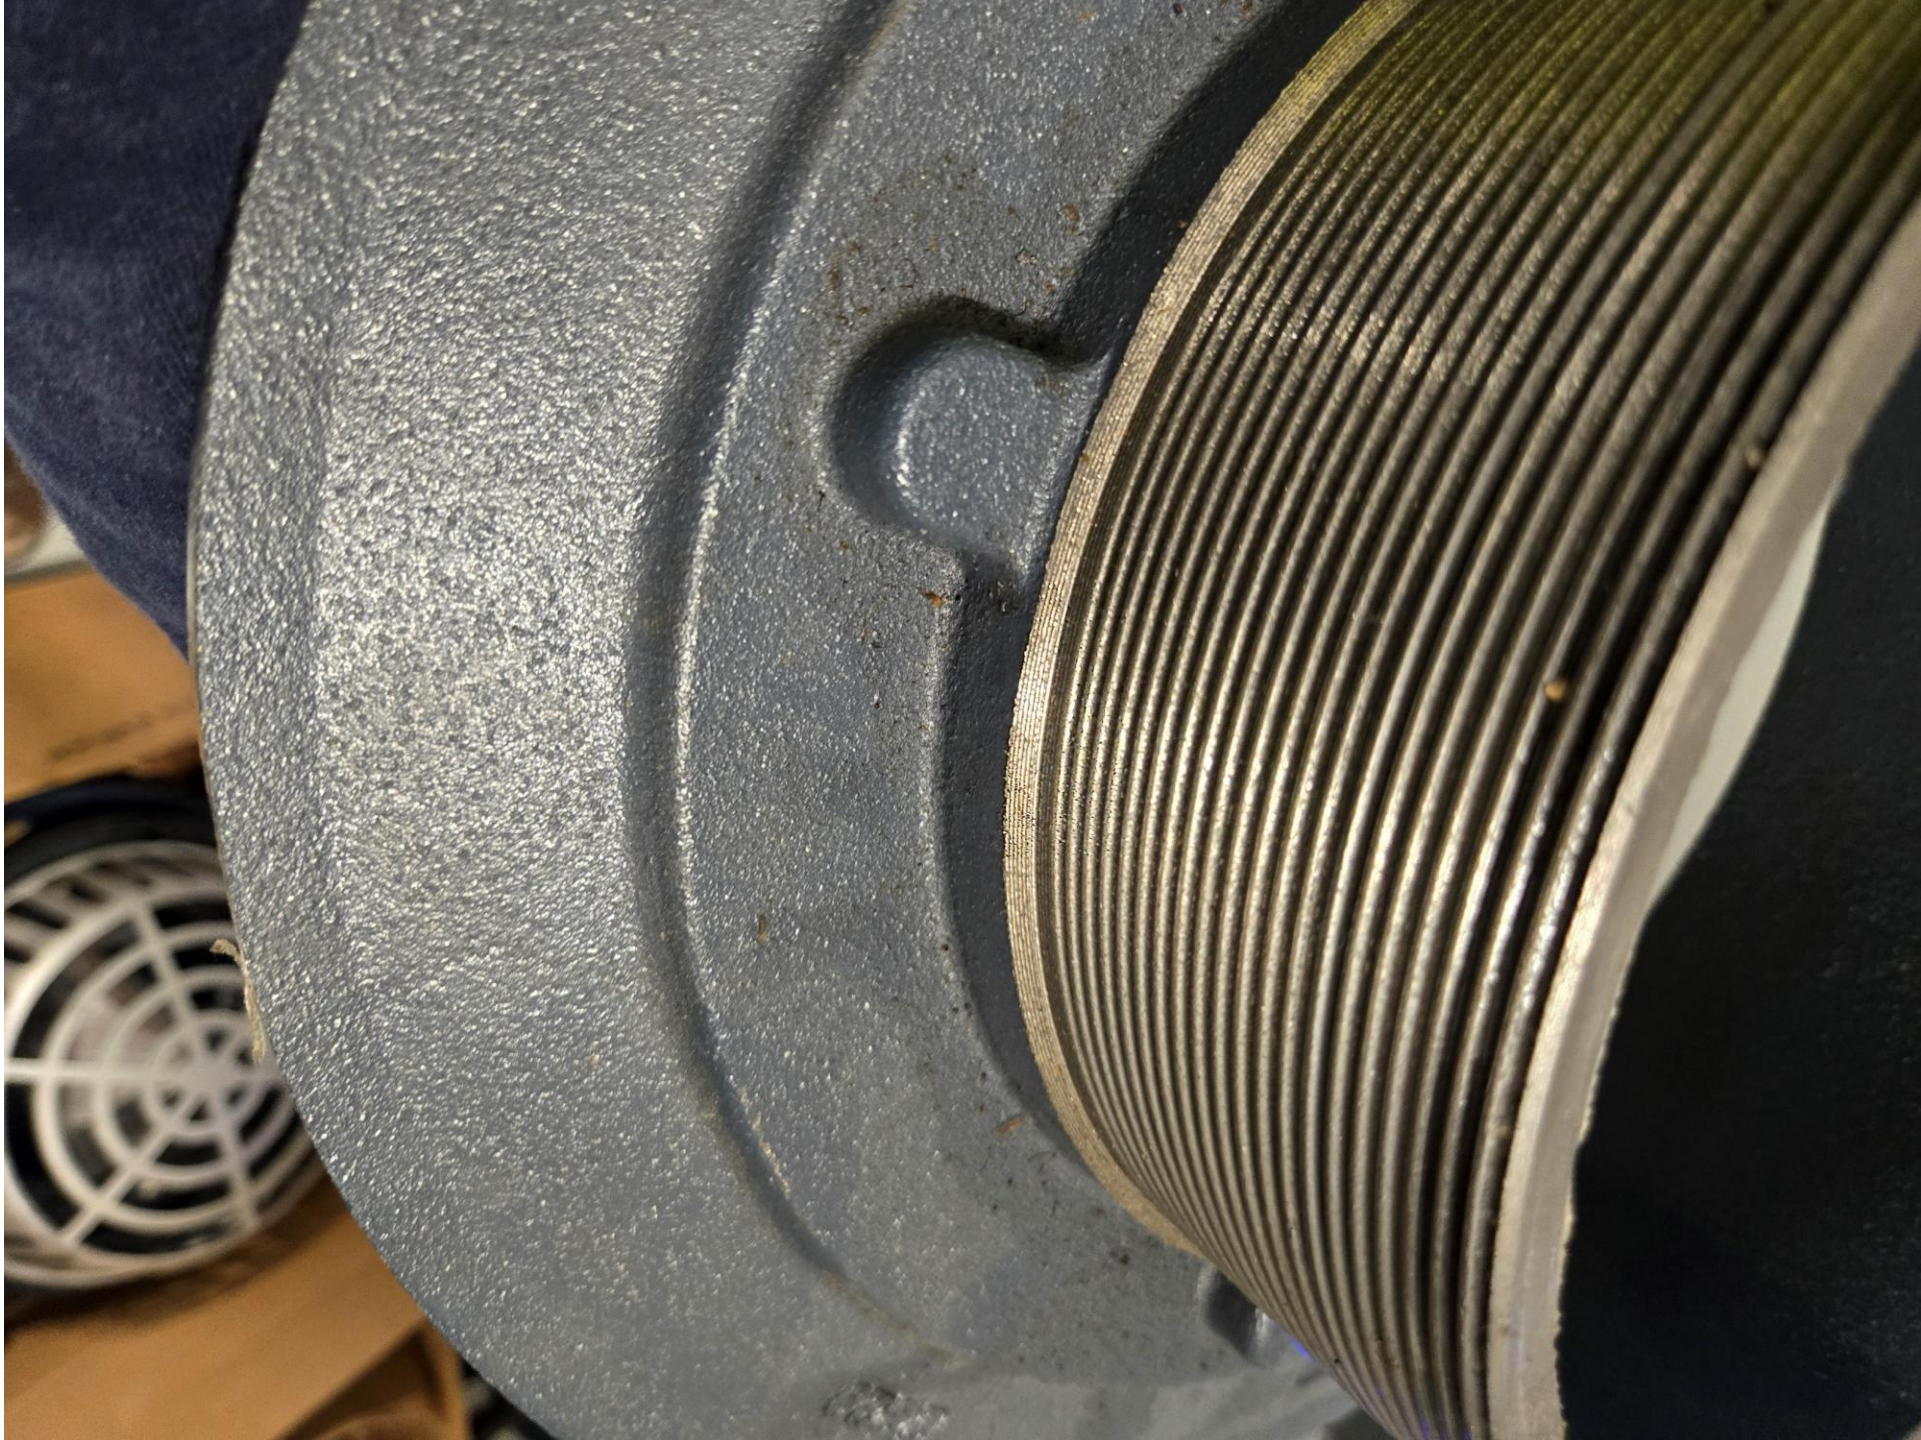
- Adjustable roof drains are not designed for static water pressure!
- **DO NOT** plug these drains
- Pressure will cause water to leak through threads and gaskets in drain assembly into roof
- Over time volume of water in the roof increases
- Roofer gets blamed for “leaking roof”
- When in fact the water is going through the drain assembly

- Multiple cases where the drains were plugged intentionally or by debris (and the general contractor knew)
 - One case plumbing wasn't done, but they wanted the roof installed. So, they plugged primary and secondary drains. Up to 18 inches of water at drains for months
 - Another case debris from construction plugged 8 of 24 drains on roof. General Contractor knew about it for over a year
 - Rain would back up onto roof
 - 1-2 inches of water inside roof system
- Builders risk considered it an “occurrence” each time it rained and claimed the \$250,000 deductible applied each time it rained. So, they owed nothing for multimillion dollar losses of the roofs
- Multiple cases of this around the country
