January 14-16, 2026
42nd CRCA Trade Show & Seminars

I Wouldn't Do That If I Was You...

Current Technical Roofing Issues From Field Forensics

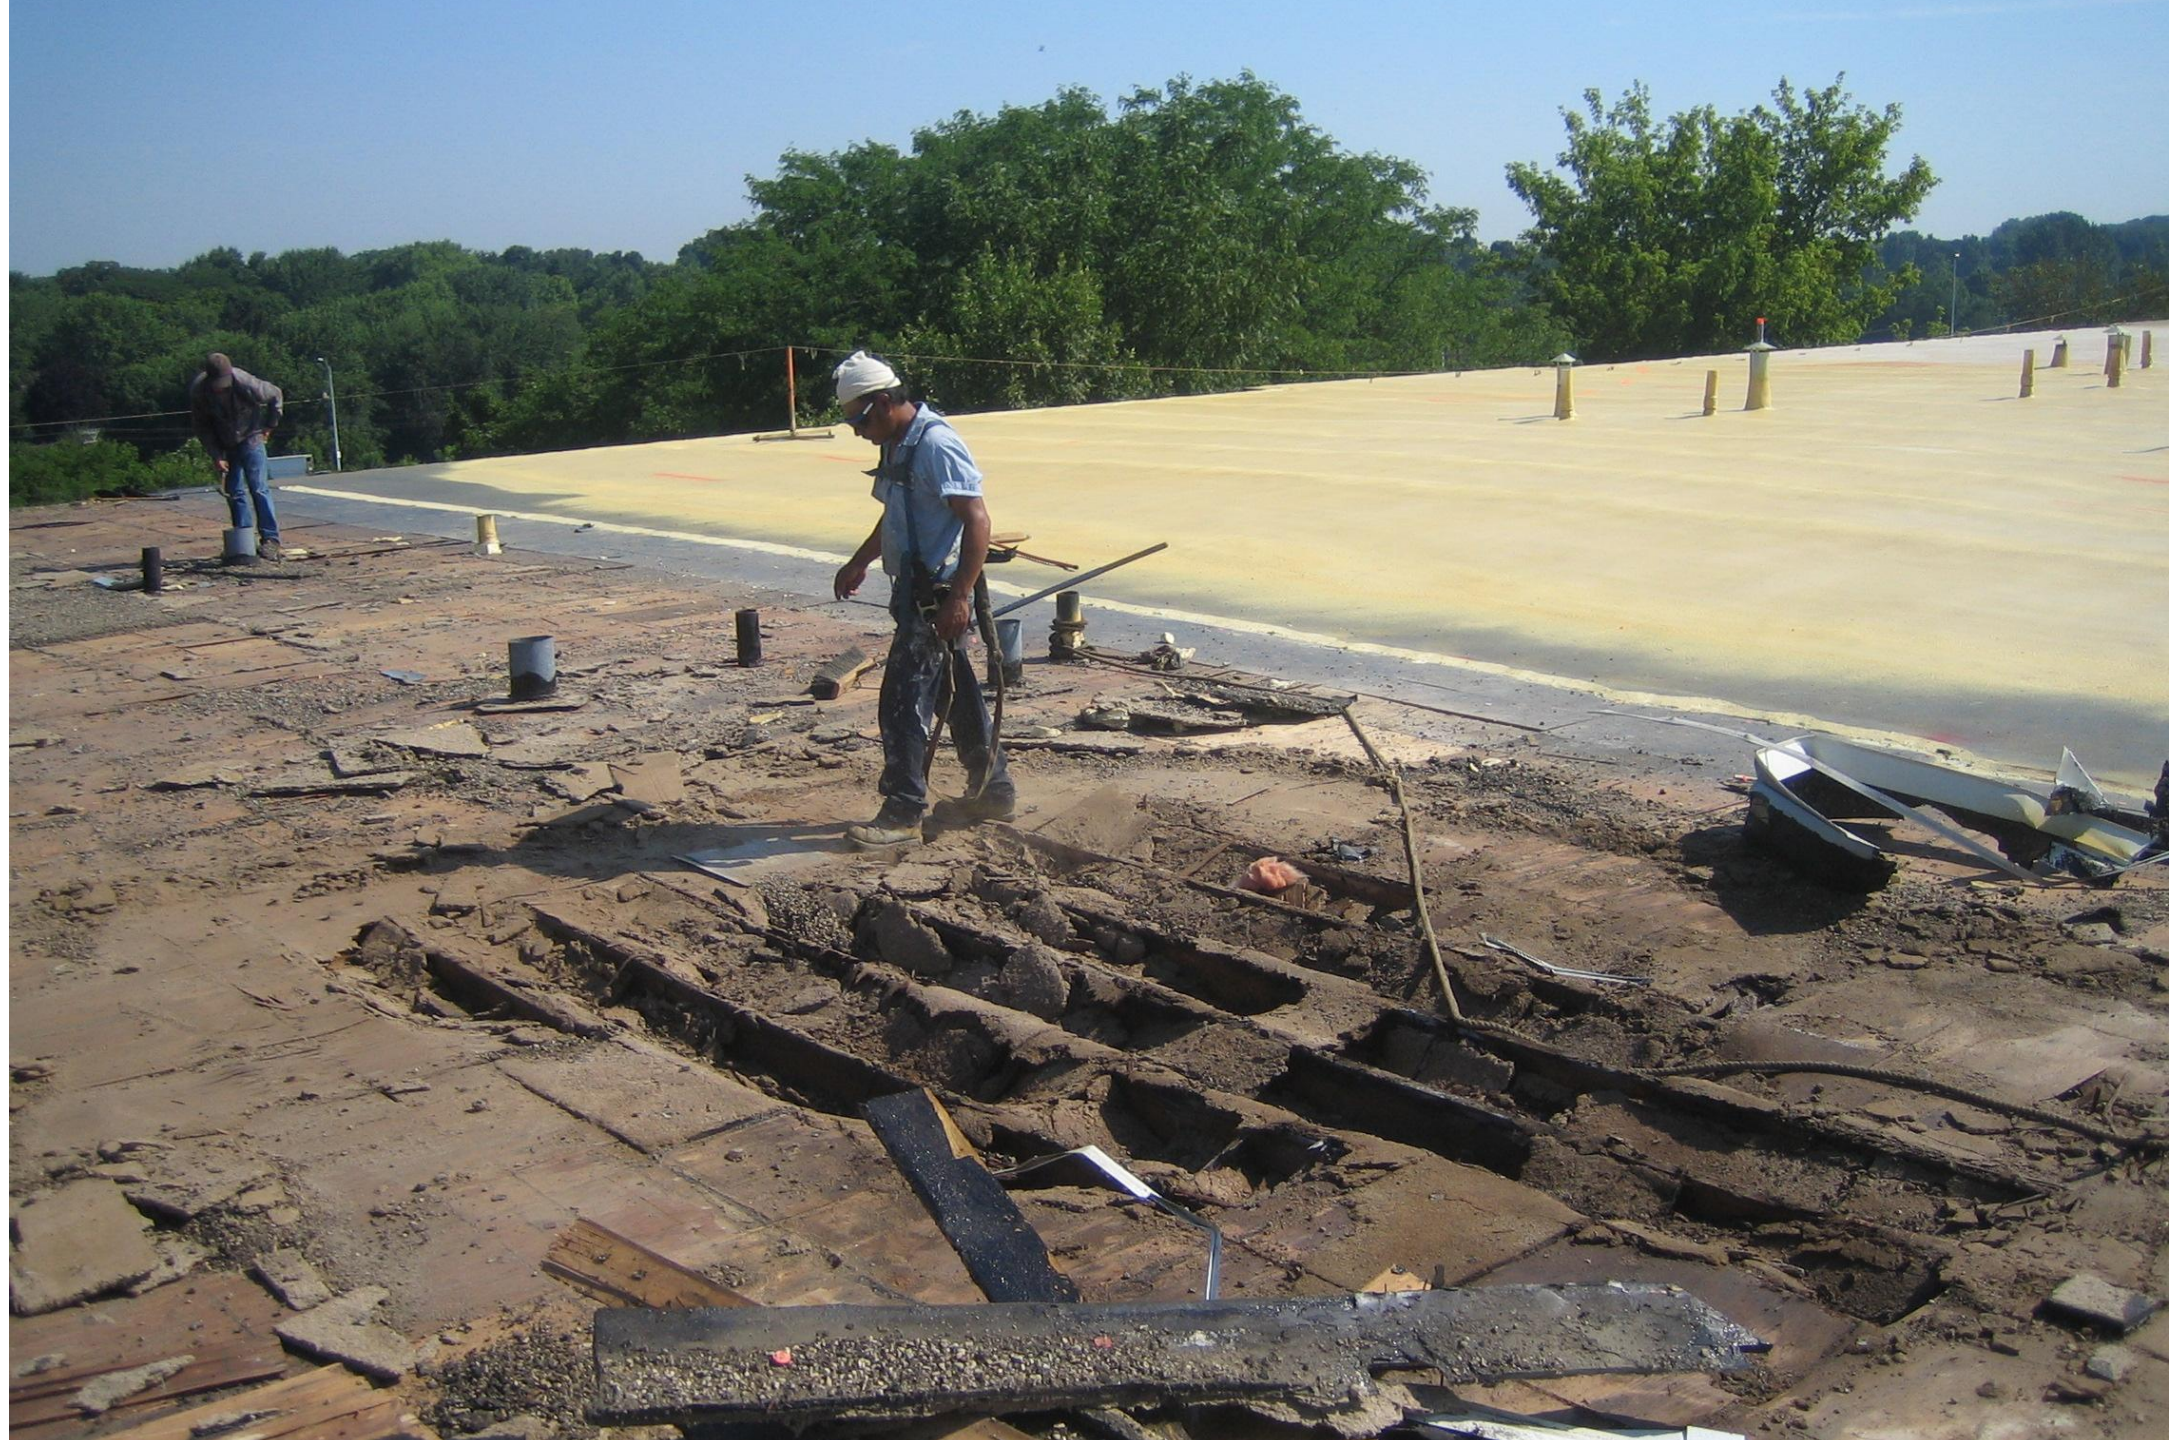
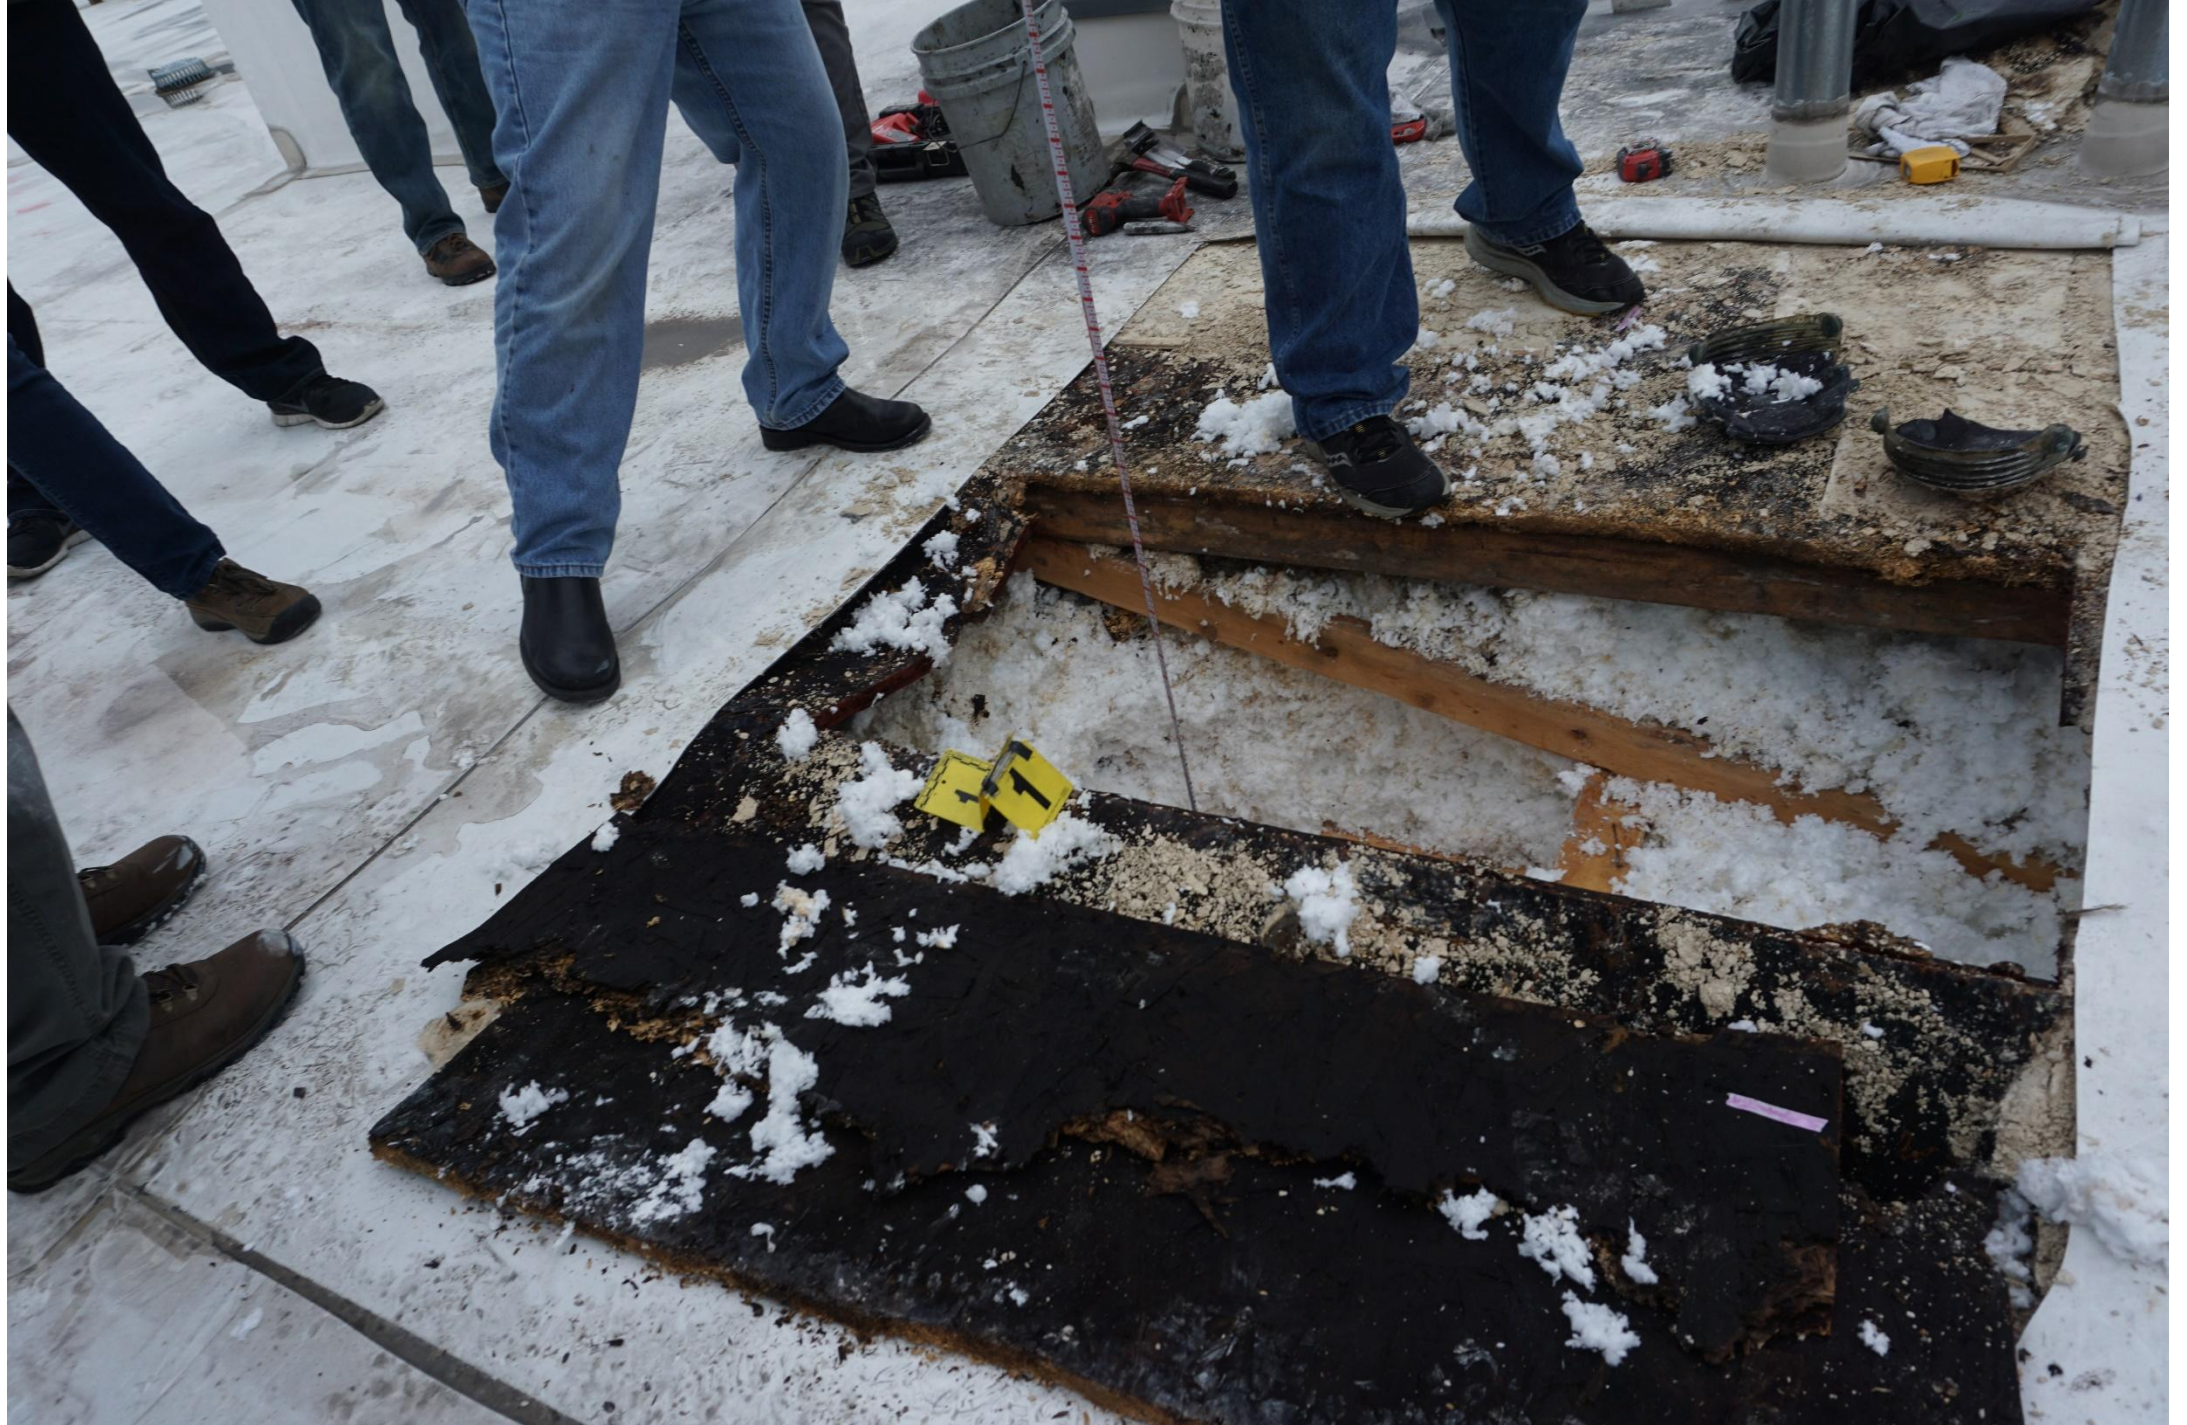
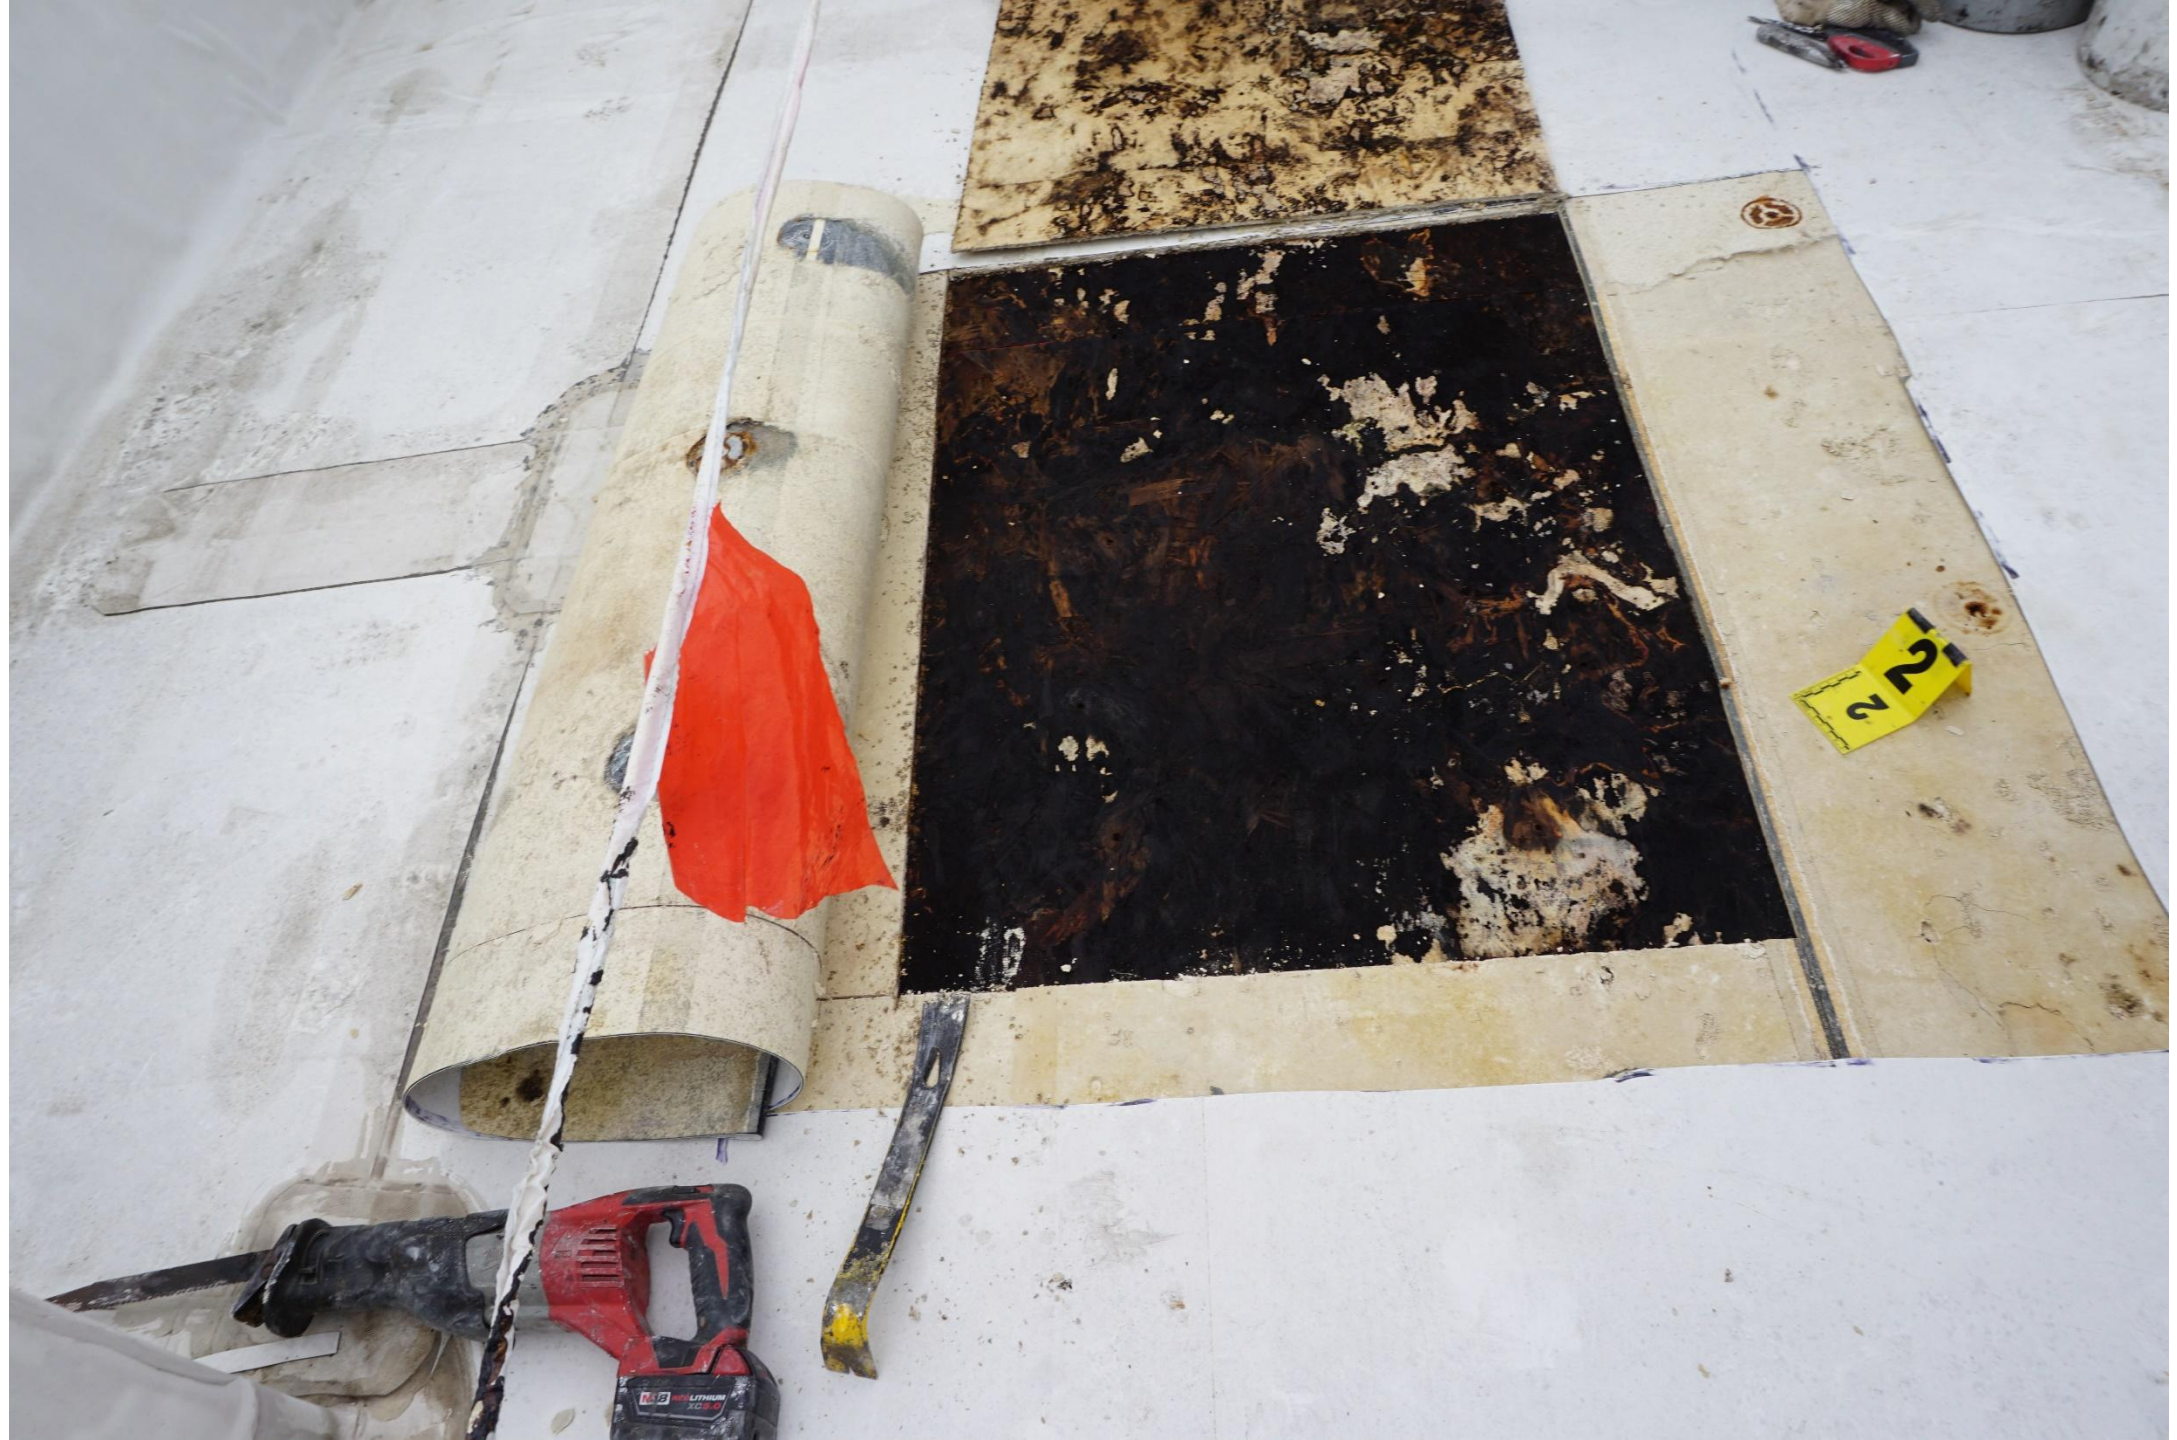
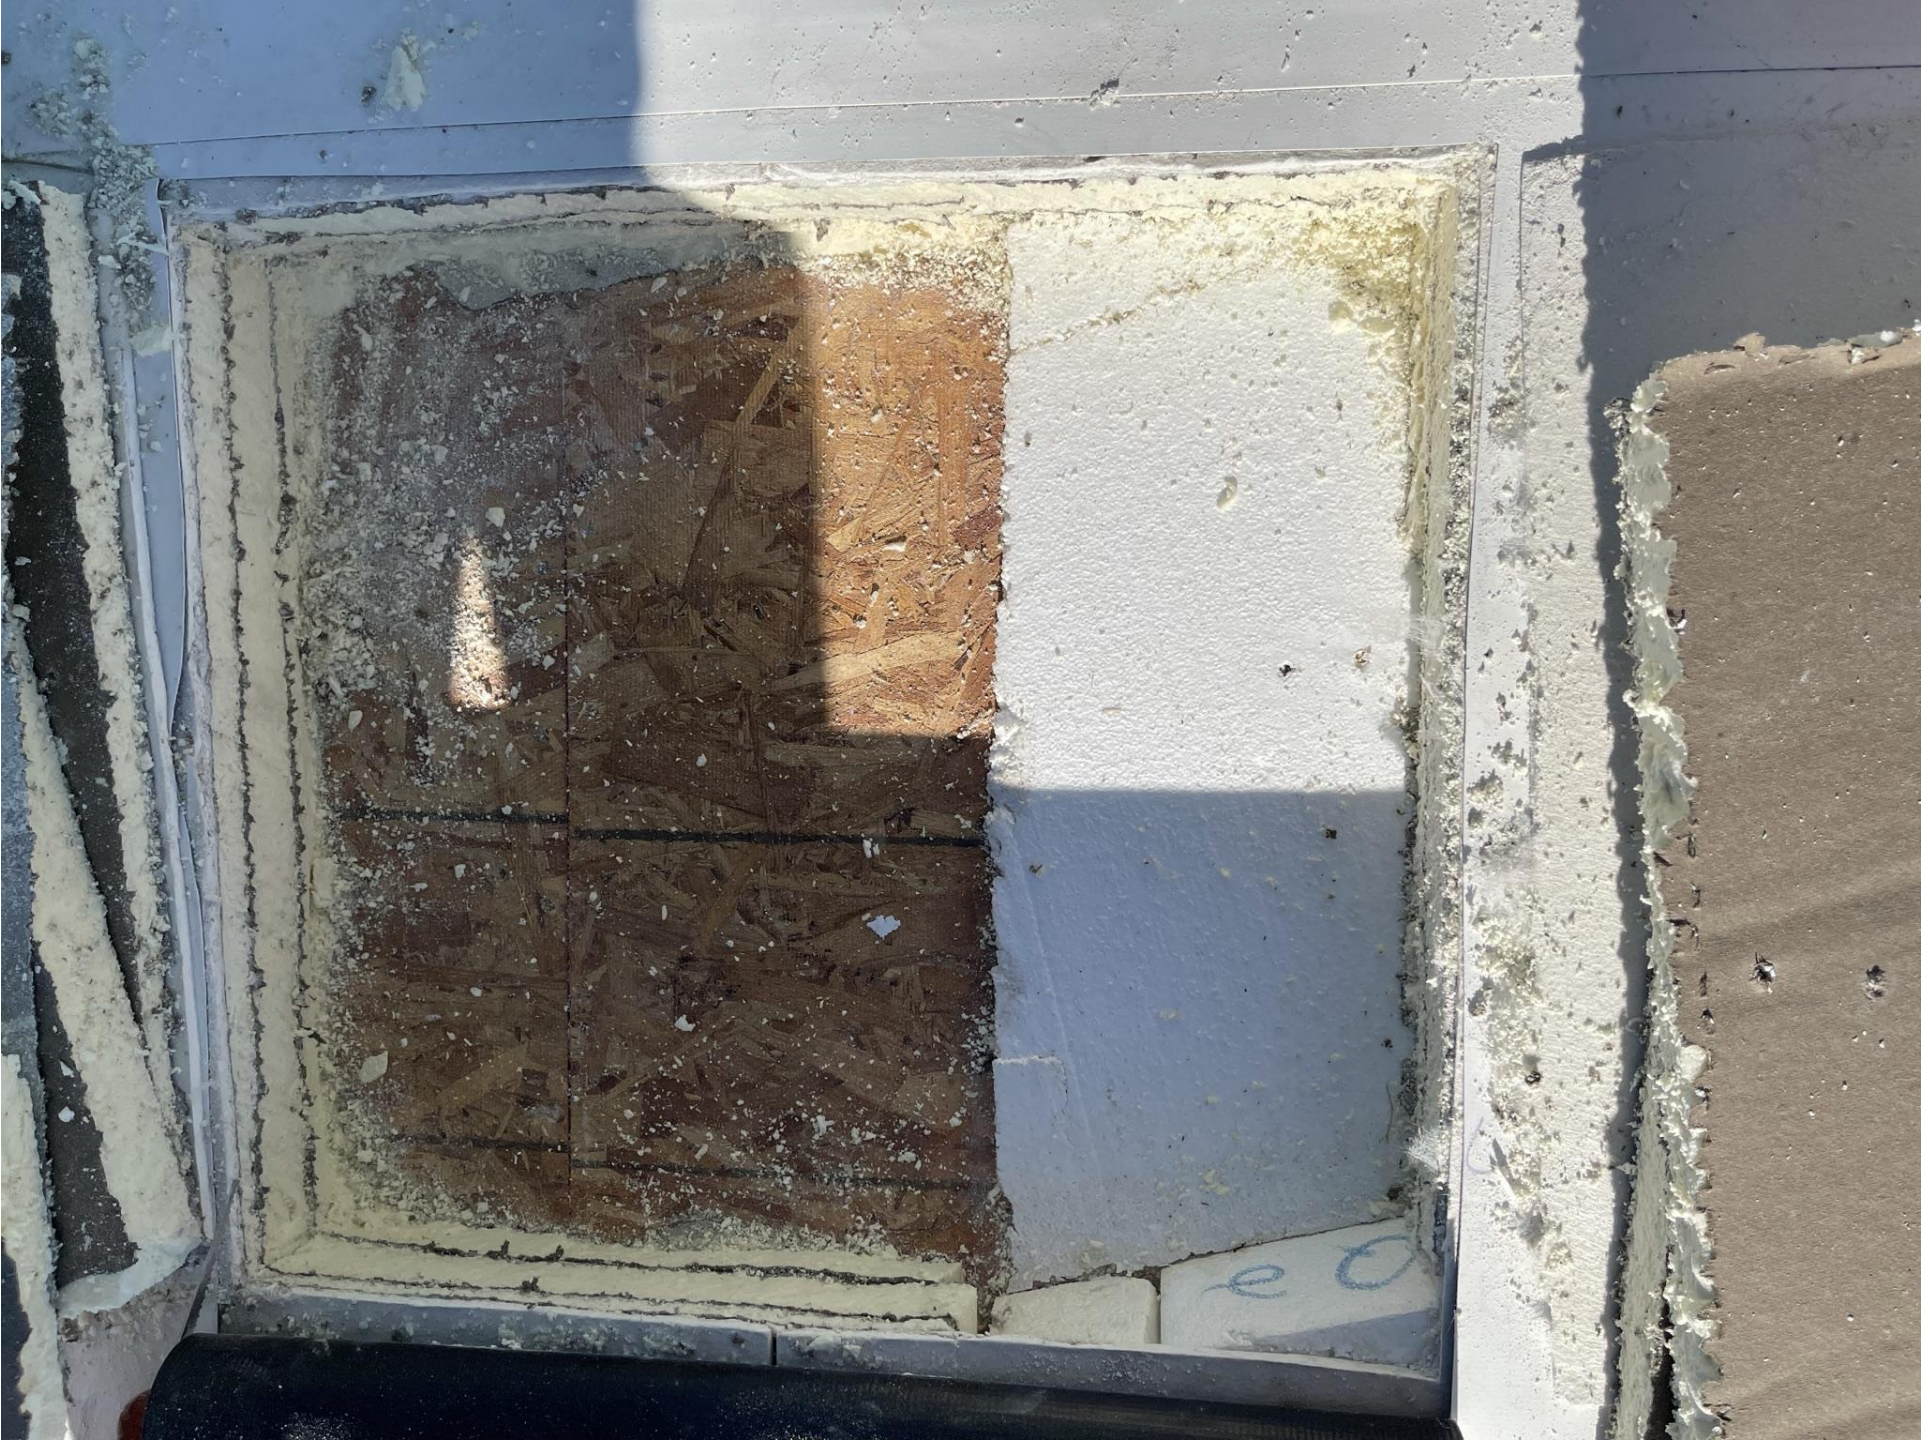
- Even when everyone agreed what went wrong, roofer was drug along in legal proceedings
- There have been variations of this scenario
- 99.99% ultimately blamed on Designer of Record's choice for cold roof
- Fix?
 - Repair moisture damage
 - Place insulation above roof deck
 - Keep the roof deck warm and not a condensing surface
 - As little as R-5 to R-10 has been anecdotally shown to prevent the decay
 - Experience shows that code required insulation will protect the roof deck even without sealing and ducts or penetrations
- See *Professional Roofing – Know the Facts*, March 2022 for article

- Ultimate fix...Don't build them like that!
- Insulation above deck
- **Can I vent it?...Maybe.**
- General rule has been that low slope roof do not lend themselves well for passive venting.
 - Active venting has it own risks
 - Single case in Southern Wisconsin where owner opted to vent.
 - Somewhat unique case where the apartment is a perfect square with venting space (inadvertent) and in a very windy corridor adjacent to interstate.
 - Continuous vents cut into all parapets
 - But it appears to be working (moisture readings and data loggers)
